Service Note		
Product	Description:	Service note no.
Lucia	Amplifier channels swapped	SNo-T201

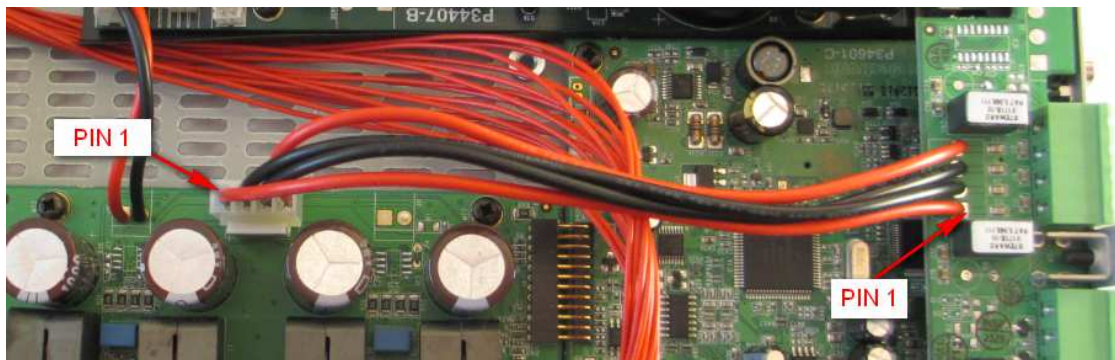
We have seen a few incidents where the amplifier channels in a Lucia product have been swapped. That means Channel 1 by accident is connected to Output 2 and vice versa.

The correct mounting of the wires. Pin 1 to pin 1. 2 to 2, 3 to 3 and 4 to 4. That can be done either by unsoldering the wires for relocation or to unplug and replace in the connector.

To fix this error the 4 wires have to be relocated as shown below:
