## Service Note

Product	Description:	Service note no.
<b>M5000</b>	<b>Mono input sence doesn't work</b>	<b>760 10 T055</b>

Modification For High Temp Stability on SUM-PCB (M5201-3):

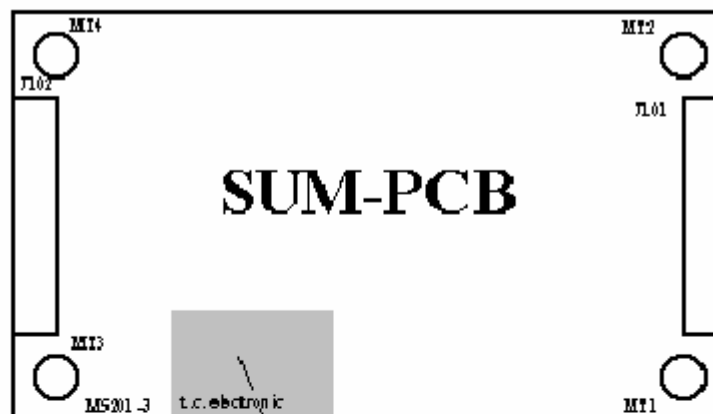
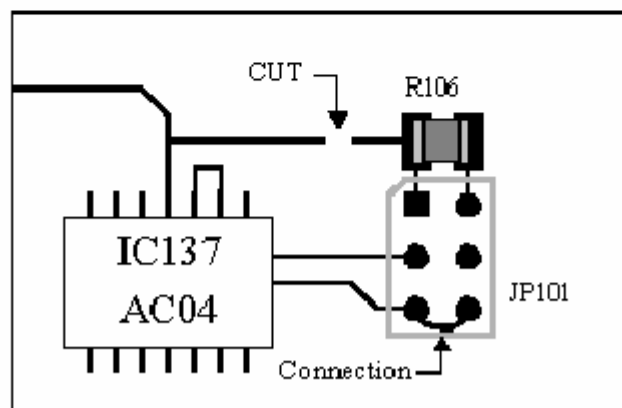
We have noticed that under special circumstances, due to a combination of high temperature and component spread it may be possible that an error occurs. The error is heard as randomly occurring noise clicks. This problem is due to timings' problems at the SUM-PCB. To cope with this problem in the easiest way for you (and us) we will ask you to do the following simple action to solve the problem.

Start separate the DSP-PCB (M5001-3) from the DIR-PCBs (Sandwich existing of M5201-3(SUM-PCB) and M5202-3(ADR-PCB)) by removing the 4 screws at the solderside of PCB M5001-3. Then when having separate these PCBs you have to make one track cut and one short as shown on figure.
