Service Note		
Product	Description:	Service note no.
M5000	Modification to avoid E04 when warm	71210T057

This modification concerns only M5000s with serial no. **between 280000 and 281720**.

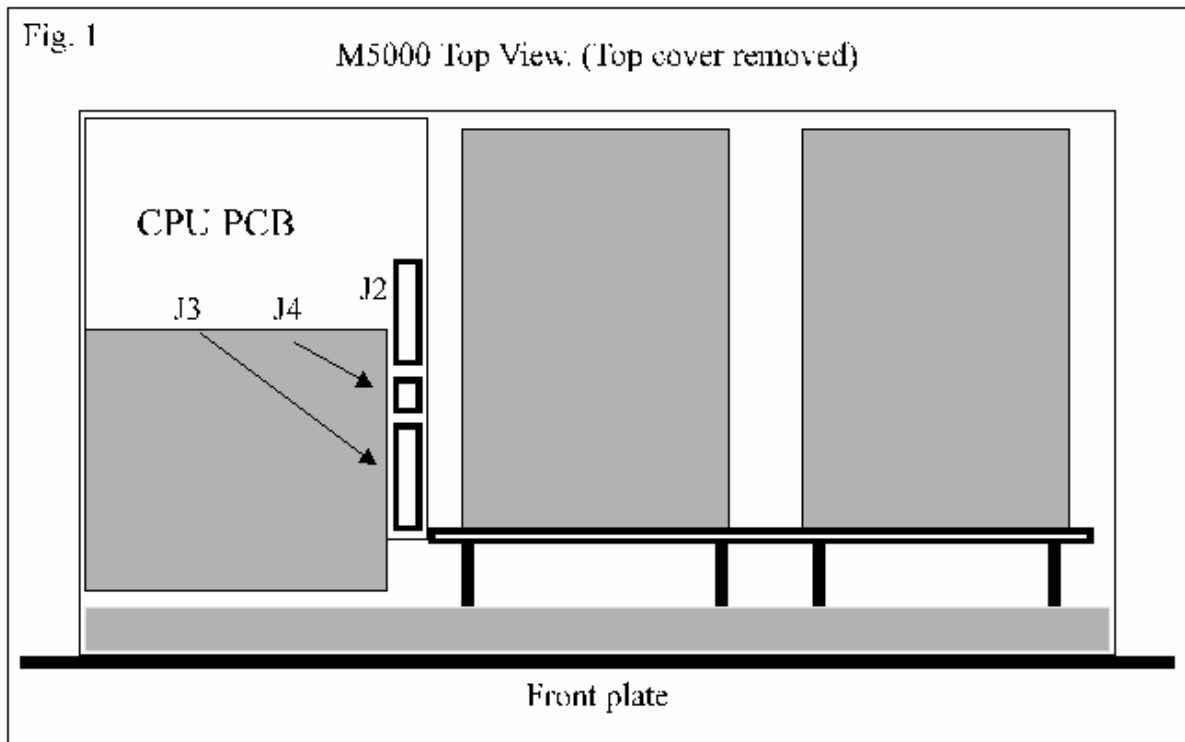
A combination of warm environment, low main voltage and electrically noise might cause the error message E04.

1. Disconnect power
2. Remove the top cover and the bottom cover.
3. Remove the 3 cables to the CPU-PCB. The 3 cables are connected to J2, J3 and J4. See fig. 1.

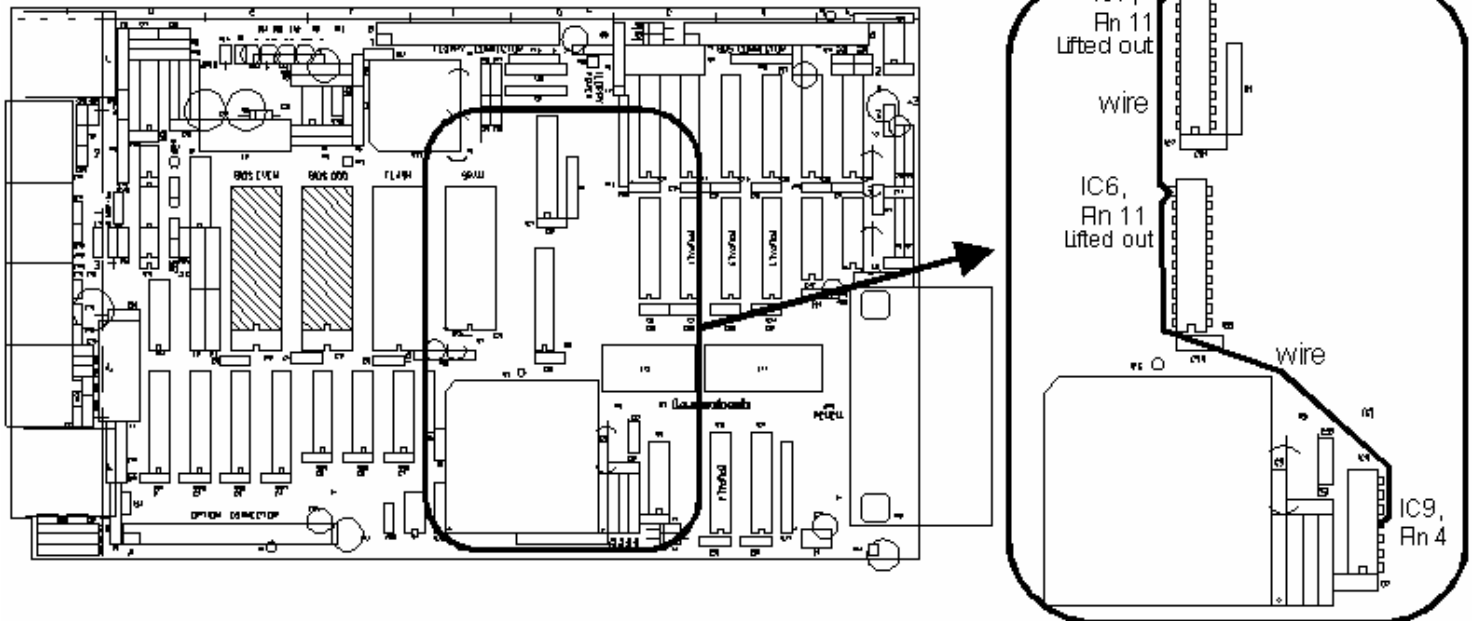
Fig. 3:

After this modification the signal called AS* is no longer connected to IC6 and IC7.

Instead the signal called RAS* is connected to IC6 and IC7.

- Lift out (carefully) pin 11 at the two chips called IC6 and IC7 on the CPU PCB. See fig. 3.

- Solder a wire from IC6 pin 11 (lifted out) to IC9 pin 4.

7. Solder a wire from IC6 pin 11 (lifted out) to IC7 pin 11 (lifted out).
8. Mount the CPU PCB again with the 2 screws and the 2 jack nuts.
9. Mount the 3 cables again.
10. Mount top and bottom cover.
