Service Note		
Product	Description:	Service note no.
Wizard	Hardware Corrections for wizards	720 10 T028

Corrections Wizard products:

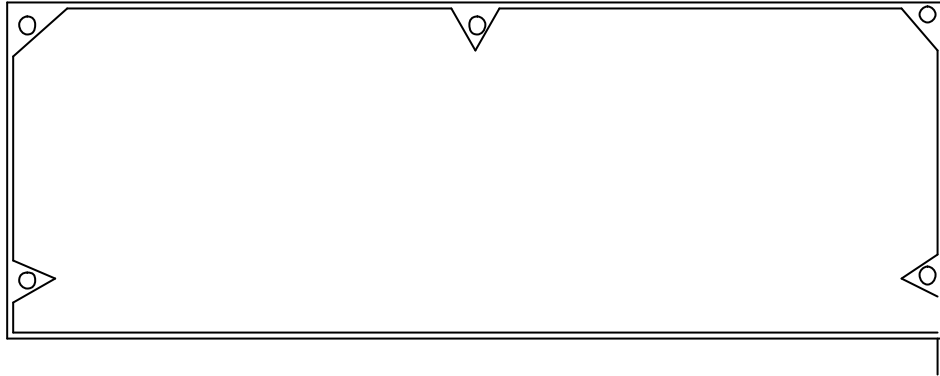
Top cover with stuck on alu foil, with the nescessary cut outs

- #1** Check if IC 8 is ISSI brand. If it is replace IC8 and battery.
- #2** Problems with word clock. Change R296 from 3M3 to 10k.
- #3** Lock problems on S/P-DIF input at 96k. modif. At IC48 (correction sheet 1701).
- #4** Check if IC35, IC36 and IC41 is the right type (33079).
- #5** If version 2 mic amp is mounted always replace with version 5. -If version 3 is mounted look if it is updated (If not replace with version 5).
- #6** Pedal input update correction sheet 1657, 1658. Remember to remove old correction if updating.
- #7** Ic 6 on the PLL-print change to 74AHC00, and the C7 og C13 Change to 56pF.
- #8** Cut outs in the foil where the screws come through the top cover. That must be done before the foil is clued to the top cover according to the enclosed drawing.
