Service Note		
Product	Description:	Service note no.
Gold Channel	IC38 on Main Board ver. 5	720 10 T032

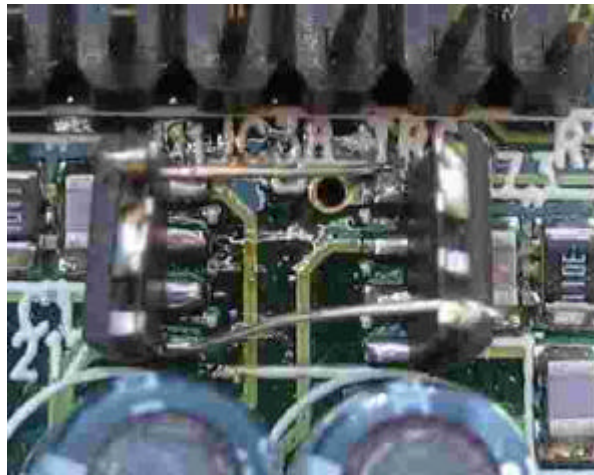
IC38 on GoldChannel main board version 5 is actually two 5532 dual op-amps in order to obtain a better channel separation.

The two 5532 op-amps are fitted upright standing on one of their side the pads on the circuit board as shown below:

For the 5532 to the left:

IC pin No.:	Connect to:
1	pin1 on the circuit board
2	pin2 on the circuit board
3	pin3 on the circuit board
4	pin4 on the circuit board
5	no connection
6	same IC pin 7
7	see above
8	wire to pin8 on the circuit board

For the 5532 to the right:

IC pin No.:	Connect to:
1	same IC pin 2
2	see above
3	no connection
4	wire to pin4 on the circuit board
5	pin5 on the circuit board
6	pin6 on the circuit board
7	pin7 on the circuit board
8	pin8 on the circuit board

It is not necessary to fix the ICs with silicone after repair as done in the factory modification - if the ICs have been properly mounted and soldered.
