Service Note

Product	Description:	Service note no.
Gold Channel	Replace 10 ohm resistors at Mic. Amp. PCB	720 10 T034

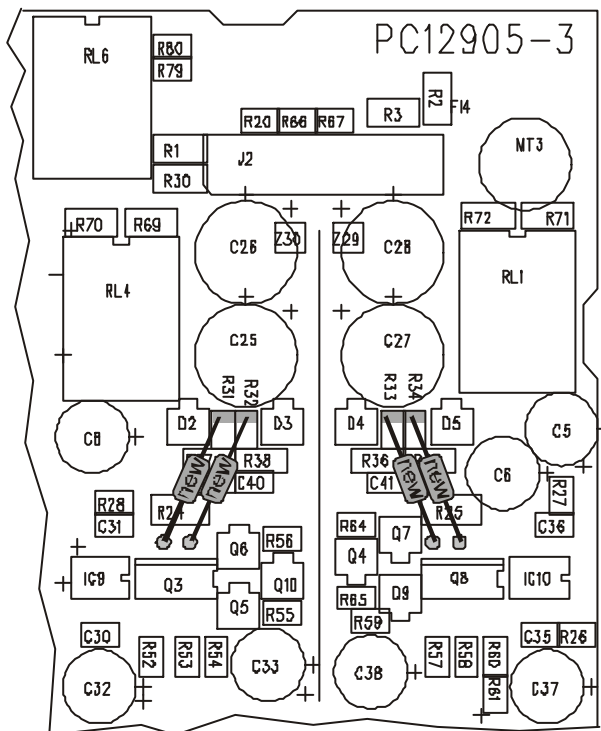
Figure 1: Mic. Amp. PCB, PC12905-3

None - if the resistors are ok, but if the resistors are blown, the mic/line input doesn't work properly.

1. Make a backup of the user presets on a memory card.
2. Turn Off Power and Disconnect Power Cord.
3. Remove the top lid by loosen five screws.
4. Remove R31, R32, R33 and R34 on the Mic. Amp PCB, see fig. 1 below.
5. Mount 4 new resistors. Make sure they are soldered to the correct solder pads, see fig. 1. Value for the new resistors is 10 ohm, 1/2W, 5%, SFR16S (TCcode: 100 2100 11)
It's only due to physical size the new resistors are soldered to other pads.
The function of the new resistors is exactly the same as before.
6. Mount the top lid again using the five screws.
7. Connect power.
8. Load in the user presets - if they were deleted.
