Service Note		
Product	Description:	Service note no.
<b>D22</b>	<b>Upgrade to 4 x Delay time (5200ms)</b>	<b>720 10 T0 46</b>

This note only concerns units with serial no. lower than 2000990.  
The upgrade should only be carried out by qualified technicians.  
TC item numbers are shown in brackets ( )

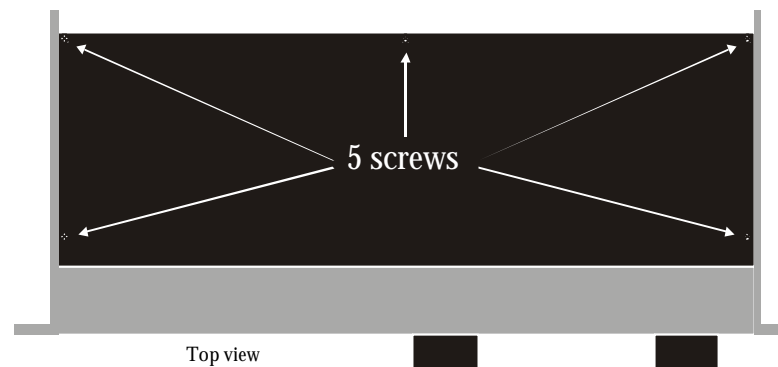
Fig. 1: Screws on top lid

- A. Use a PCMCIA card to make a copy of the user presets.
- B. Turn Off Power and Disconnect Power Cord.
- C. Remove the top lid by loosening five screws, see fig.1.
- D. Replace the old Ex.RAM board at J13 with the new Ex.RAM board. See fig. 2.
- E. Fasten the board to the metal spacer by use of 1 screw and 1 star washer. See fig 2.
- F. Mount the foam piece on top of the Ex.RAM board in the end opposite of the screw if the foam wasn't fitted by TC. See fig. 2.
- G. Mount the top lid.
- H. Load in application software version 2.50 (or higher).
- I. If necessary; load in the user preset. Presets are compatible.

1. Use a PCMCIA card to make a copy of the user presets.
2. Turn Off Power and Disconnect Power Cord.
3. Remove the top lid by loosening five screws, see fig.1.

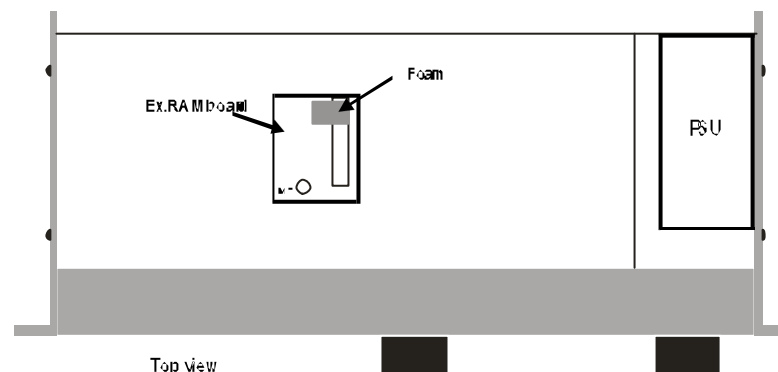
Fig. 2: Location of Ex.RAM board and foam.

12. Solder in the new 68 pin connector (523056011) as J13
13. Mount the main board again.
14. Mount the new Ex.RAM board at J13. See fig. 2.
15. Mount the foam piece on top of the Ex.RAM board in the end opposite of the screw if the foam wasn't fitted by TC. See fig. 2.

16. Fasten the board to the metal spacer by use of 1 screw and 1 star washer. See fig 2.
17. Mount the top lid.
18. Load in application software version 2.50 (or higher)

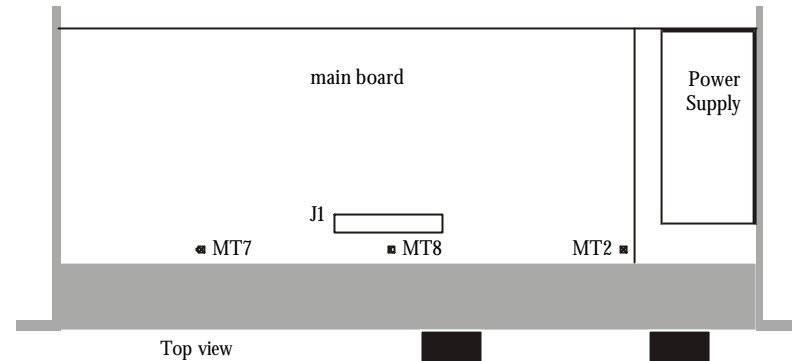
Fig. 3: Location of J1, MT7, MT8 and MT2

4. Disconnect front connector, J1, see fig. 3.
5. Remove screws at MT7, MT8, MT2 on the main board.
6. Remove 9 screws at the XLR connectors, see fig. 5.

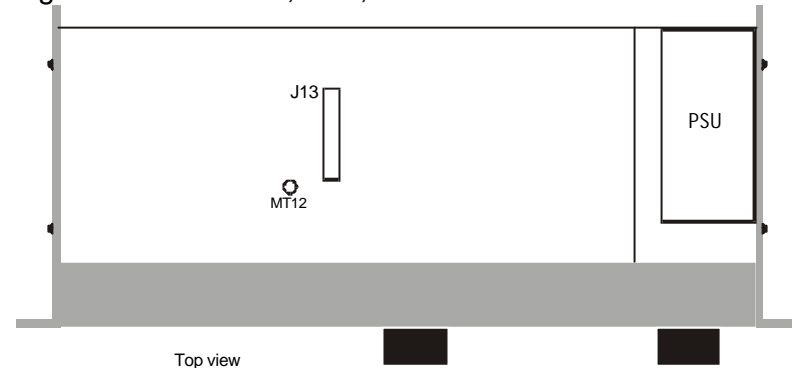
Fig. 4: Location of MT12 and J13.

10. Push the main board into the front profile a little to free the connectors from the back panel, then lift out the board.
11. Mount the metal spacer (566007030) at MT12 by use of 1 screw (563005030) and 1 star washer (565052030). See fig 4.

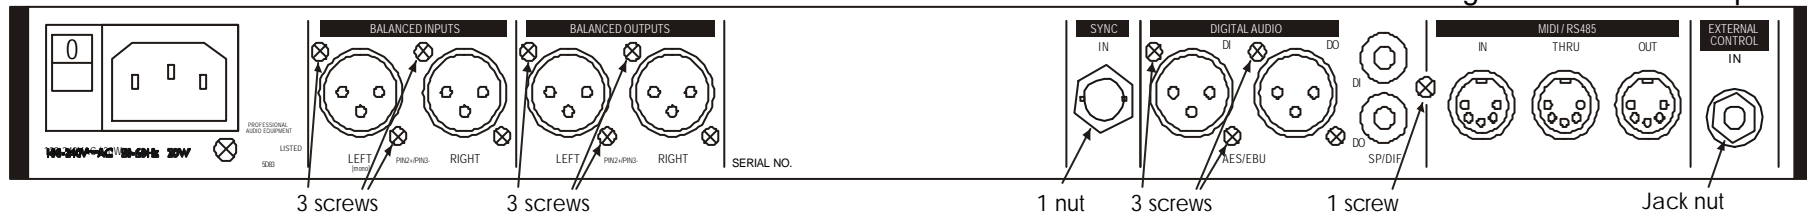
Fig. 5: Screws at back panel.

7. Remove the screw at the SPDIF in/out connector, see fig. 5.
8. Remove the nut at the SYNC IN connector, see fig. 5.
9. Remove the jack nut at the EXT. IN connector, see fig. 5.
