Service Note		
Product	Description:	Service note no.
G-System	Hum sound when connected to lower jacks	740 10 T003

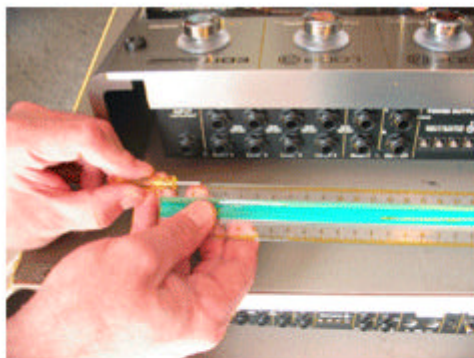
Screwdriver apporx 1.5 cm

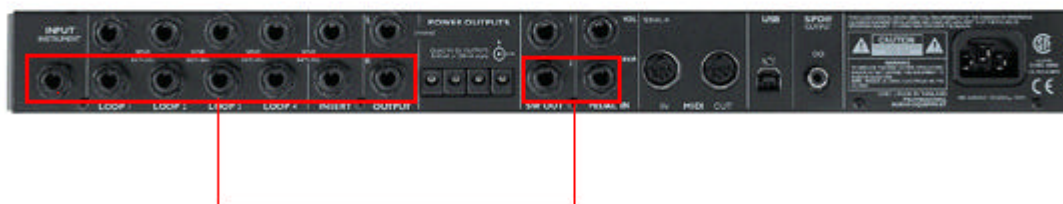
Fig.1

Inputs that need to be modified!

The easiest way to disable the spring contact is to use a small tool, for example a small screw driver, to bend the spring in the jack connector, please be careful not damaging the connector. This modification has to be done on J9, J7, J26, J6, J5, J4, J3, J2. See fig.1

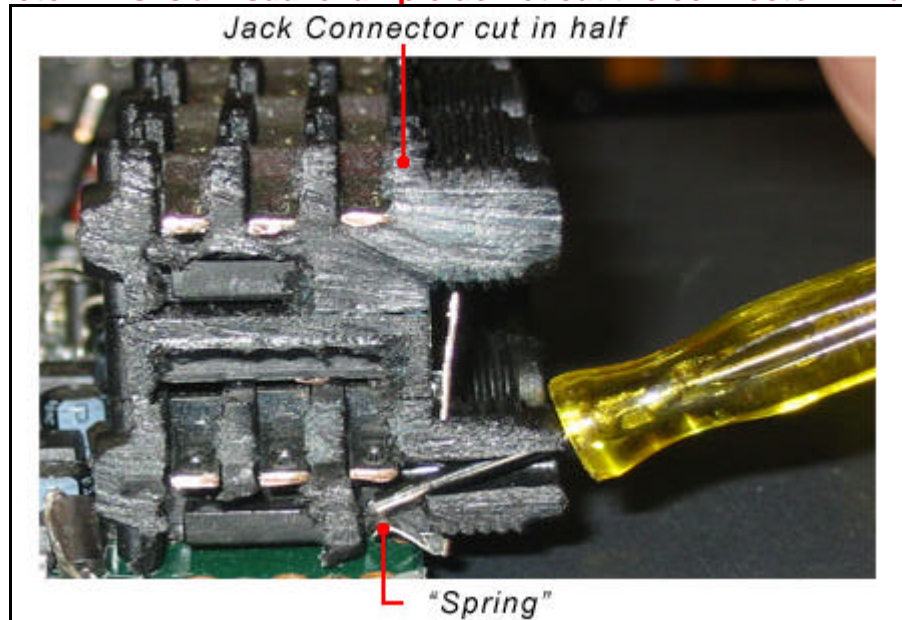
Fig.2

This “spring”-contact has to be disabled on all Double-jack connectors. It shorts cgnd, dgnd and agnd when a connector is inserted see fig.2

Note: This is a visual example do not cut the connector in half!

Double check that the connection is disabled. We recommend you use good lighting it's difficult to see that the spring has been bended enough.
