Service Note		
Product	Description:	Service note no.
Penguin	White noise when using effects	760 10 T023

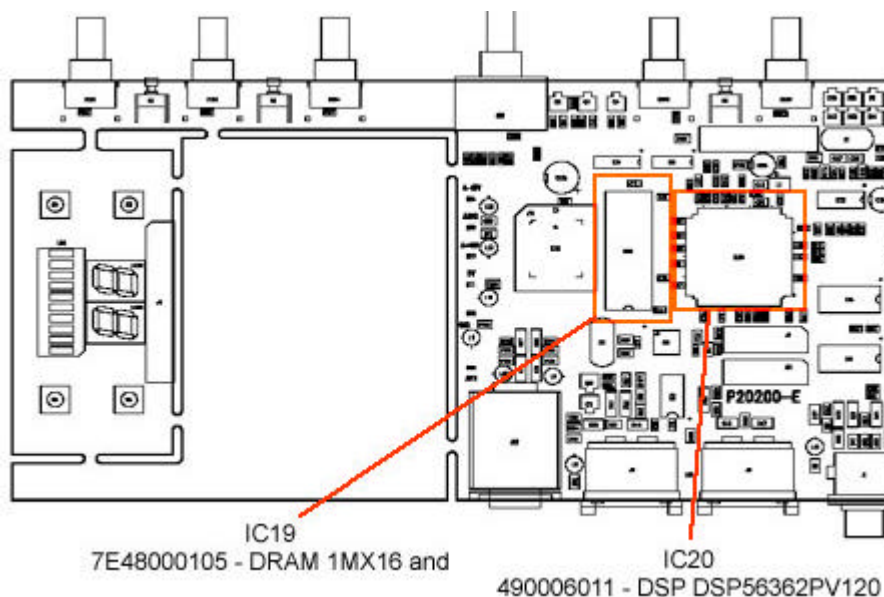
Problem: White noise from the outputs.

Description: The problem occurs when effects are switched on.

Component IC19: 7E48000105 - KM416V1000CJ-5 DRAM 1MX16 and

Component IC20: 490006011 - DSP DSP56362PV120

PTA will improve the manufacture process in the future. (it's properly because we use Lead-free soldering now, which means the process is more difficult now, and the process has to be maintained more carefully than ever before, when we used lead)

Solution: In most cases this can be repaired by re-soldering the DSP and DRAM.

1. Remove the lid of the product.
2. Examine the soldering points on the DSP and DRAM fig.1.
3. If you can't see anything wrong at first we recommend that you resolder them anyway because the lead-free tin-based solders are still relatively new and it can be difficult to locate cold/bad soldering point.
