Service Note		
Product	Description:	Service note no.
<b>Finalizer 96</b>	<b>Sample Rate Conversion gives spikes</b>	<b>SNo-T0134</b>

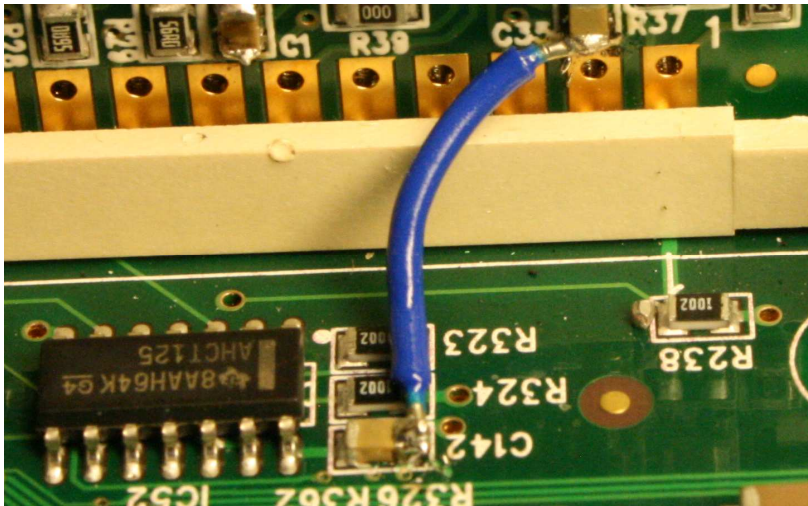
Spikes in the audio output has been reported when using sample rate conversion at any rate.

The error is related to a poor GND connection between PLL board and mainboard.

The solution is to solder a 0,28 mm<sup>2</sup> thick wire between the mainboard @ C142 and PLL board @ C35, as shown in the picture.
