Service Note		
Product	Description:	Service note no.
Motofader64	Display error	795 10 1813

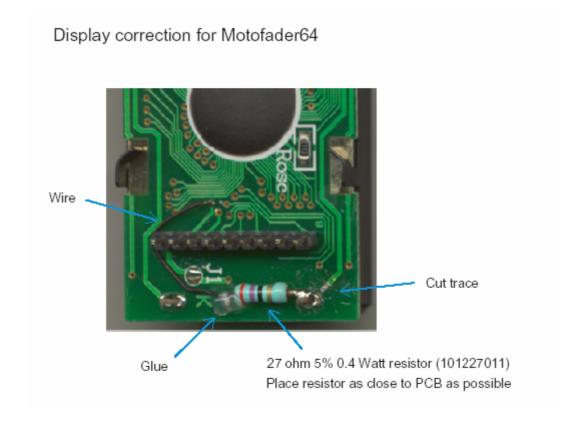
Symptoms: Due to possible overloading of the display backlight on the Motofader64, a current limiting resistor must be added. The modification is done on the display module according to attached description/drawing.

Remedy: Units received for service must be reworked with a new modified display. **Please scrap old display because of possible damage.** No change in schematics.
