Service Note		
Product	Description:	Service note no.
Nova Drive	Coils, L3 and L5 overheats	SNo-T0122

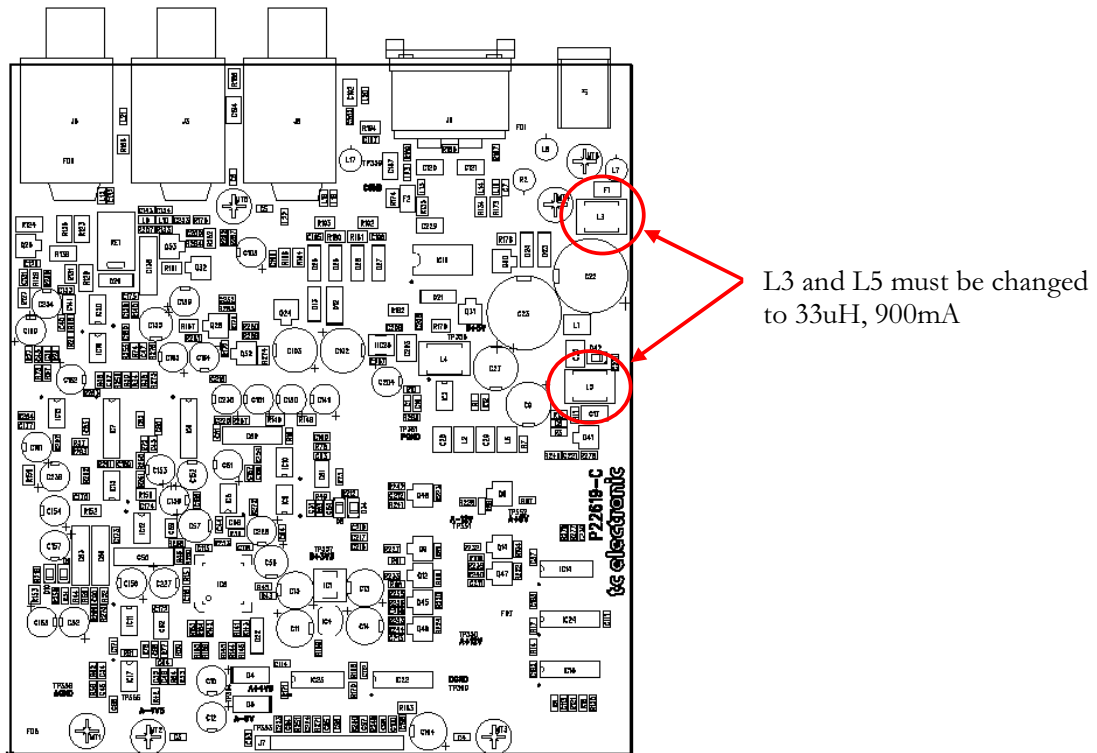
In some cases L3 and L5 overheats

When a Nova Drive is in for service these two coils must be exchanged from the original 150 uH, 420mA to 33uH, 900 mA
