Service Note

Product	Description:	Service note no.
NovaSystem	Modification of distortion board due to beeps	Sno-T084

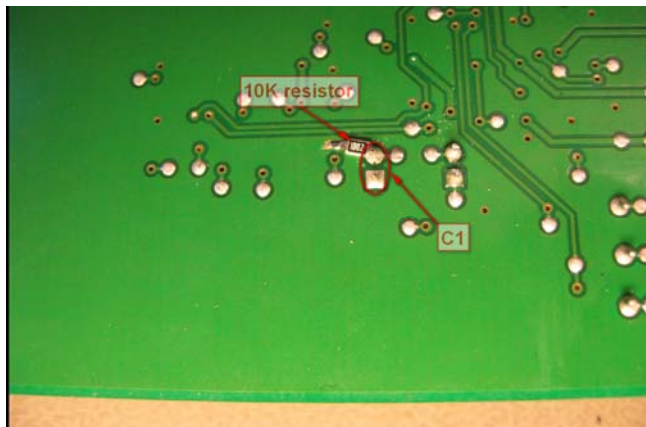
Unfortunately we discovered a fail that causes beeps in the output when using the distortion board.

1.	Add a 10K0 - 0805 SMD resistor (E15400101), from "C1" negative side to AGND plane. See Picture 1 & 2 Soldermask must be made open at resistor agnd side to solder.
2.	Rotate the "C4" Electrolytic 47uF/25V (E22002411) See Picture 3. (Electrolytic "-" side must point at silkscreen "+" side).
3.	Cut connection between C26 and "IC7" pin 8. See Picture 4
4.	Add 2pcs. 1n4148 diodes (E31001511) from "IC5" pin8 and pin9 to "IC7" pin8. See Picture 5
5.	Add a 10K0 – leaded resistor (E10501911) from "IC7" pin8 to DGND plane. See Picture 6
