Service Note

Product	Description:	Service note no.
SDI cards	Glue added on diodes	SNo-T0112

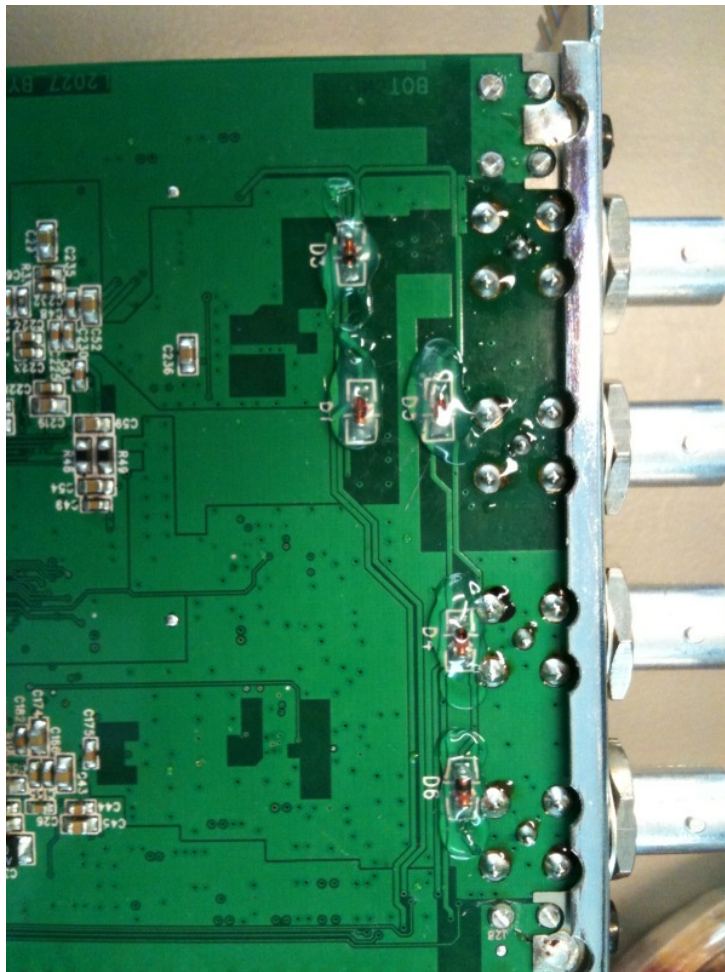
Diodes on SDI cards (only HW version 203 – identified by visible Firewire connector on the backplate) are easily broken off when mounting/dismounting the card in frames. Therefore heating glue is added according to the picture. To be added when cards are in for repair.

Heating glue to be added when cards are in for repair.
