Service Note 110

Error-Codes on TC2290 With FATR/STSA Options:

This paper describes the possible error-codes on the 2290 in connection with the fast trig /stereo sampling FATR/STSA option card (PCB #2971-02) and the associated software 29.12-30.12. Also it describes how to faultfind and correct the errors. You will need the schematics as well.

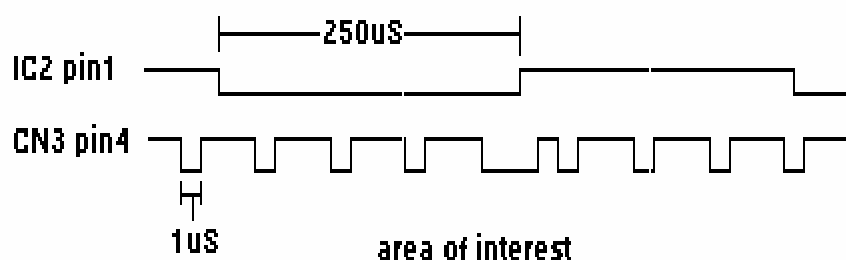
fig.2.

CN3 pin 4/8 on the slave. Trig the oscilloscope on the rising edge of FAST6 (IC2 pin 1), which is a 2kHz/50% duty cycle signal and measure at CN3 pin 4 (inverted at CN3 pin 8) the following signal:

Suppose this signal is present but the error #40 still occurs (later we return to this signal).

This signal is generated by the D-flip-flop IC13 pin 5. If not like the signal shown at fig.2, then check on the master 2290 if IC13 pin 3 receives the OPTRWSEL-signal (250 kHz/50% duty) from IC8 pin 14, if the CASTIME signal is present at IC24 pin 10, if IC28 pin 13 receives a carry-pulse from IC4 pin 15 (CA), and finally if these pulses are capable of presetting IC13 pin 5 to a high level at a low pulse on IC13 pin 4.
