Service Note		
Product	Description:	Service note no.
TC2290	Fuses On TC2290 Main Board:	706 10 T066

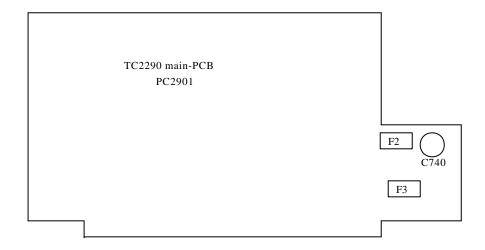
IMPORTANT: When having 2290s with s.no. lower than 512020 for repair or service please make this correction.

In order to avoid the two secondary fuses F2 and F3 to blow when extreme high tension accrues on the power network, please replace these fuses with a 400mAT type. The fuses are placed just beside the transformer on the main board.
