Service Note		
Product	Description:	Service note no.
TC2290	Updating TC2290 Main Board to FATR/STSA/SA02:	706 10 T069

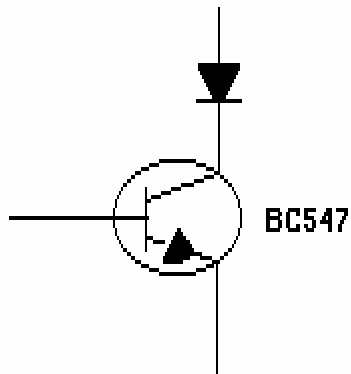
IMPORTANT: When having 2290s with s.no. lower than 510404 or 510636 for repair or service please make this correction.

In connection with FATR/STSA-options there are two more points to be aware of.

1. (2290s with s.no. lower than 510636) jumper R608 must be removed to R606. Just cut out R608.
2. (2290s with s.no. lower than 510404) transistor Q101 (BC547) on main-board must be replaced by a BC547 with a diode in collector.
