## Service Bulletin

Date Issued	06 February 2001
Products Covered	VoicePrism serial number < 7002251
Issue	Some early units of VoicePrism have failed mic phantom power
Description	<p>The capacitor specified for mic input coupling has incorrect voltage rating. These capacitors should be removed on units returned for service. Audio performance is not affected by this modification.</p> <p>VoicePrism units shipped from Vtech before the above date are affected. Units manufactured after this date have been modified by ECO1248</p>

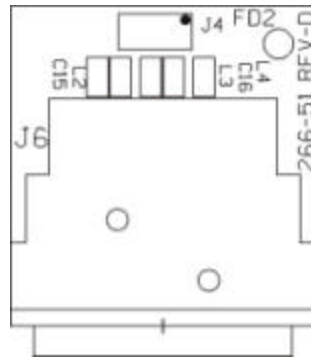
Illustration below shows location of C15 and C16. Front of unit is at bottom of illustration.

On units returned for service remove C15 and C16 from PDC0146 VoicePrism Display Board. Capacitors are located on mic input board behind connector J4. Illustration below shows location of board.
