Service Note		
Product	Description:	Service note no.
Mary (40200-GAB)	Voltage exceed specification	795 10 1881

This service note is only intended for TC-service Denmark/USA

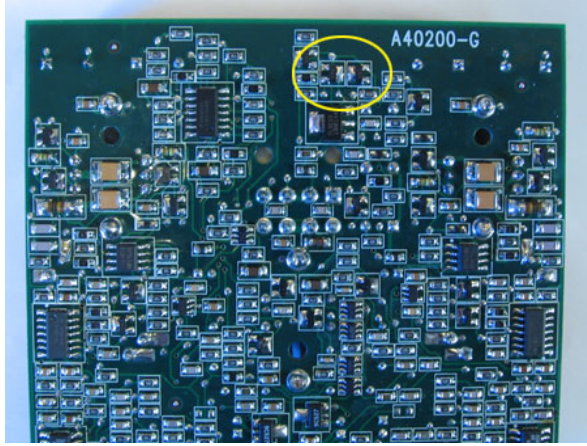
Fig.1.

Fail rate still too high due to exceeded gate voltage and zener has been added for protection.

1. The location of the modified area on PCB-40200 fig.1.
2. Mount a Zener diode from Collector Q33 to Emitter on Q37 see fig.2
3. Cathode towards the Emitter Q37 see fig.3.
4. Always remember to update the unit to the latest software version. In this case you must have 1.64 or later.
