Service Note		
Product	Description:	Service note no.
BM5A BM5A Comp. BM6A MK II BM12A	Bad connection in signal cable	SNo_T095

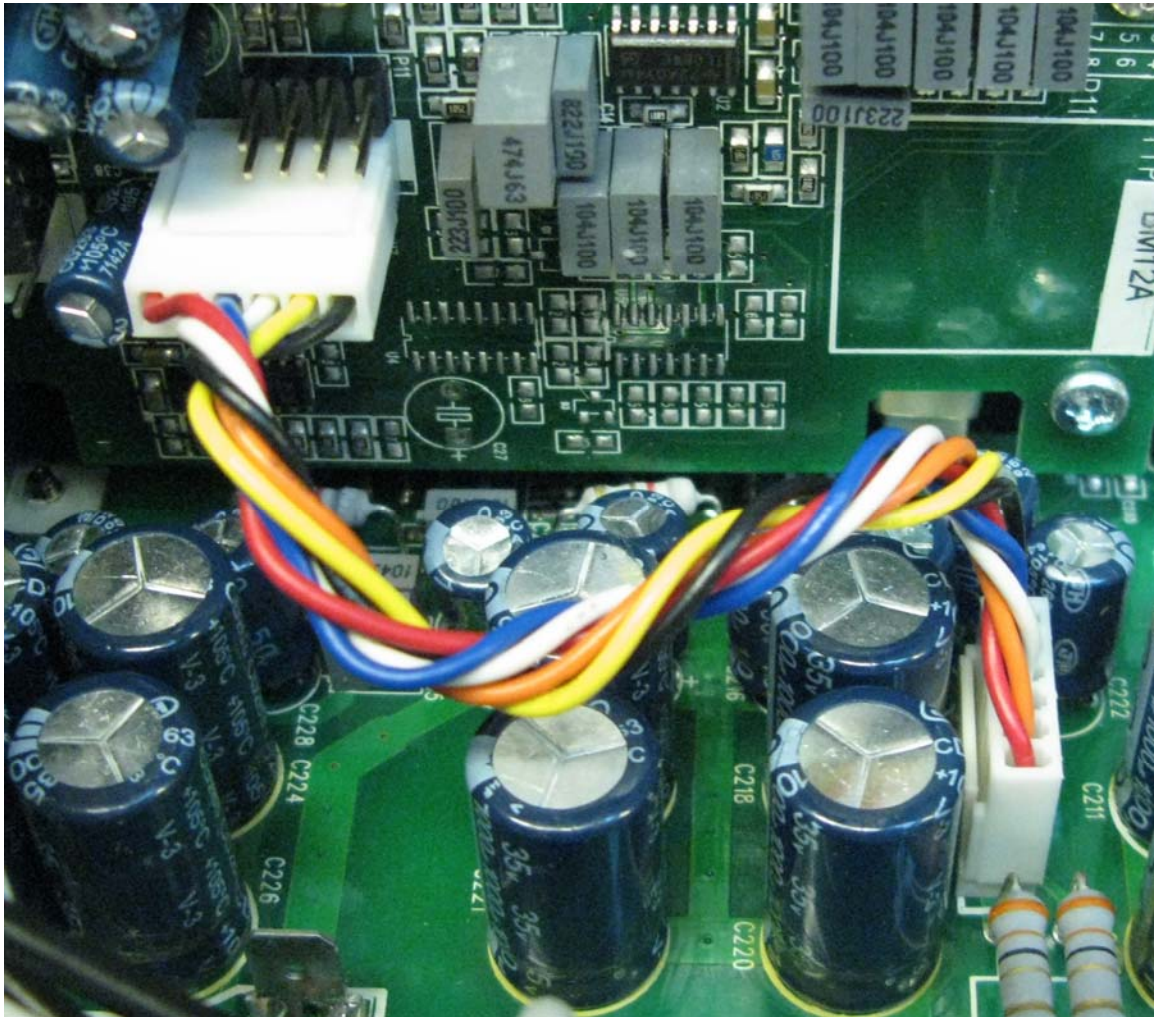
Reason for note: Recently it has been discovered that there can be a bad connection in the signal cable going from the input board to the amp board.

Actions: Wires shall be soldered directly in the PCB's.

IMPORTANT: This shall be carried out on all modules that come in for service.
