Service Note		
Products	Description:	Service note no.
System 6000 MKII	Fuse changed from 2A to 3,15AT H	SNo-T0163

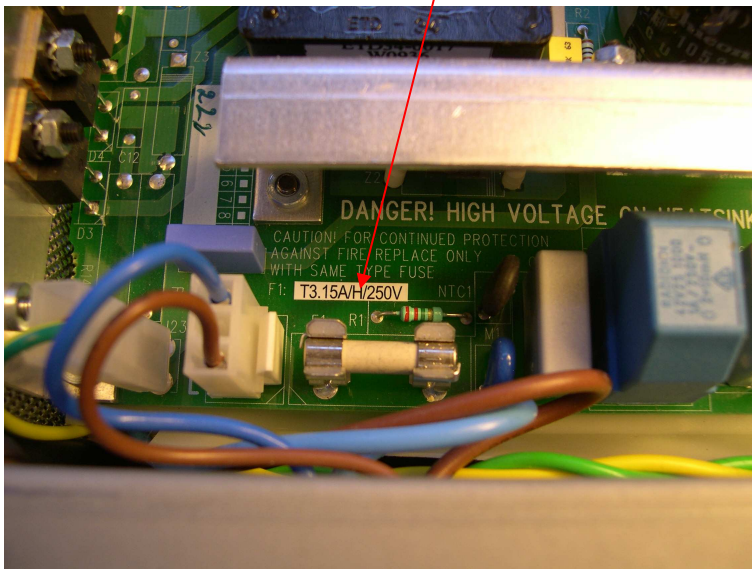
We have encountered a few incidents where the fuse in the **System 6000 MKII** PSU has blown.

In our production we have changed from the former 2A fuse to a 3,15 AT H fuse in the MKII version. The System 6000 (MKI) is still ok with the 2 AT fuse!

For System 6000 **MKII** which have a 2 AT fuse, this fuse must be changed to a 3,15 AT H type, (TC stock no 343030011). Furthermore a label (TC stock no 600134011) must be placed on the PCB as shown below.
