Service Note		
Product	Description:	Service note no.
BG500 - BH500	Transformer being loose	SNo-T0175

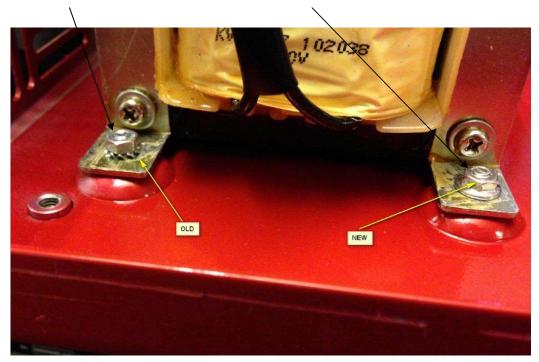
We have seen cases where the washer breaks resulting in the nut coming of as well as resulting in the transformer being loose.

The old solution with nut and washer.
The new solution with a serrated nut.

Cure is to replace the 4 nuts and washers with serrated nuts. Part number for a serrated nut is 7E56400911. This must be done for all products coming in for service.
