Service Note		
Product	Description:	Service note no.
VoiceLive Touch 2	USB audio problem	SNo-T0179

On the first batch of VoiceLive Touch 2 we have seen cases with USB audio problems.

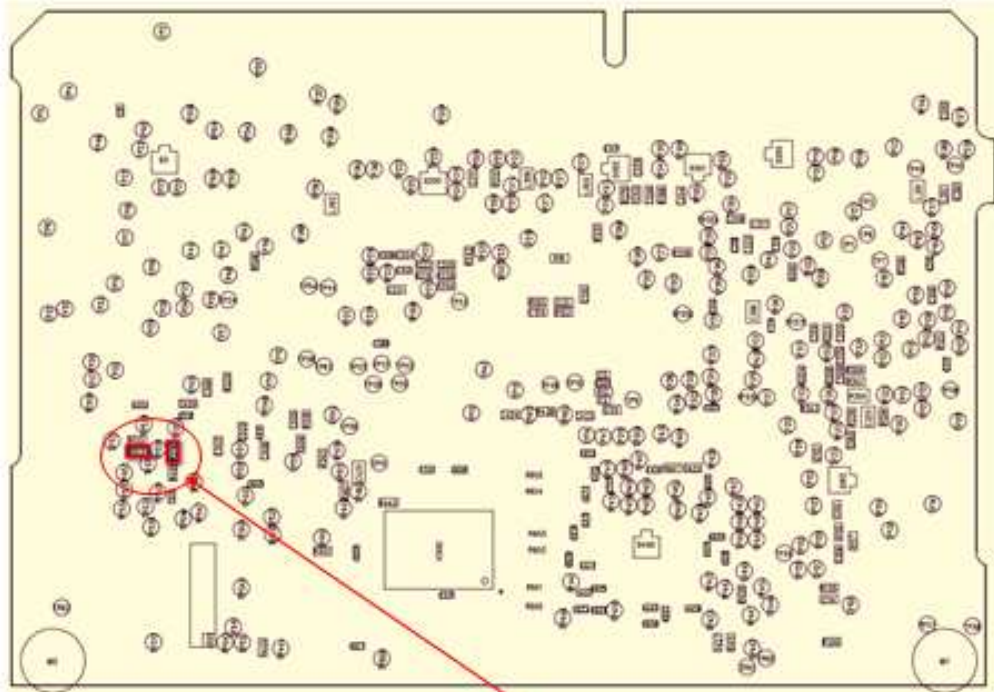
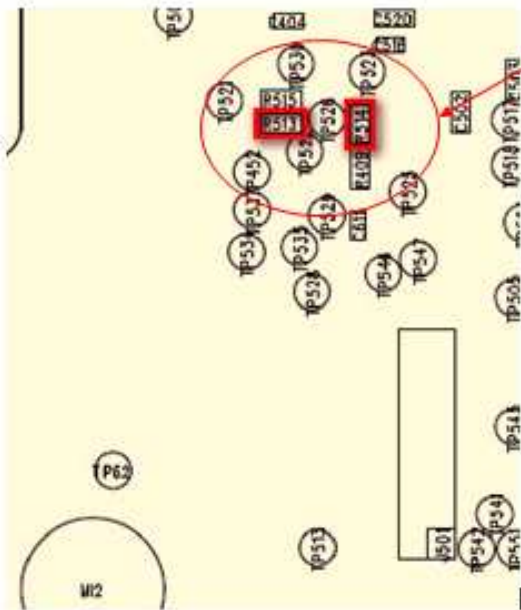
VoiceLive Touch 2 bottom view

It shows as playback- channel swapping, audio pops, clicks and / or no audio transferring via USB when recording.

On the bottom side R513 and R514 must be changed from 1 kohm to 82R5
