<b>Service Note</b>		
Product	Description:	Service note no.
<b>Impact Twin</b>	<b>Analog audio mutes</b>	<b>SNo-T0181</b>

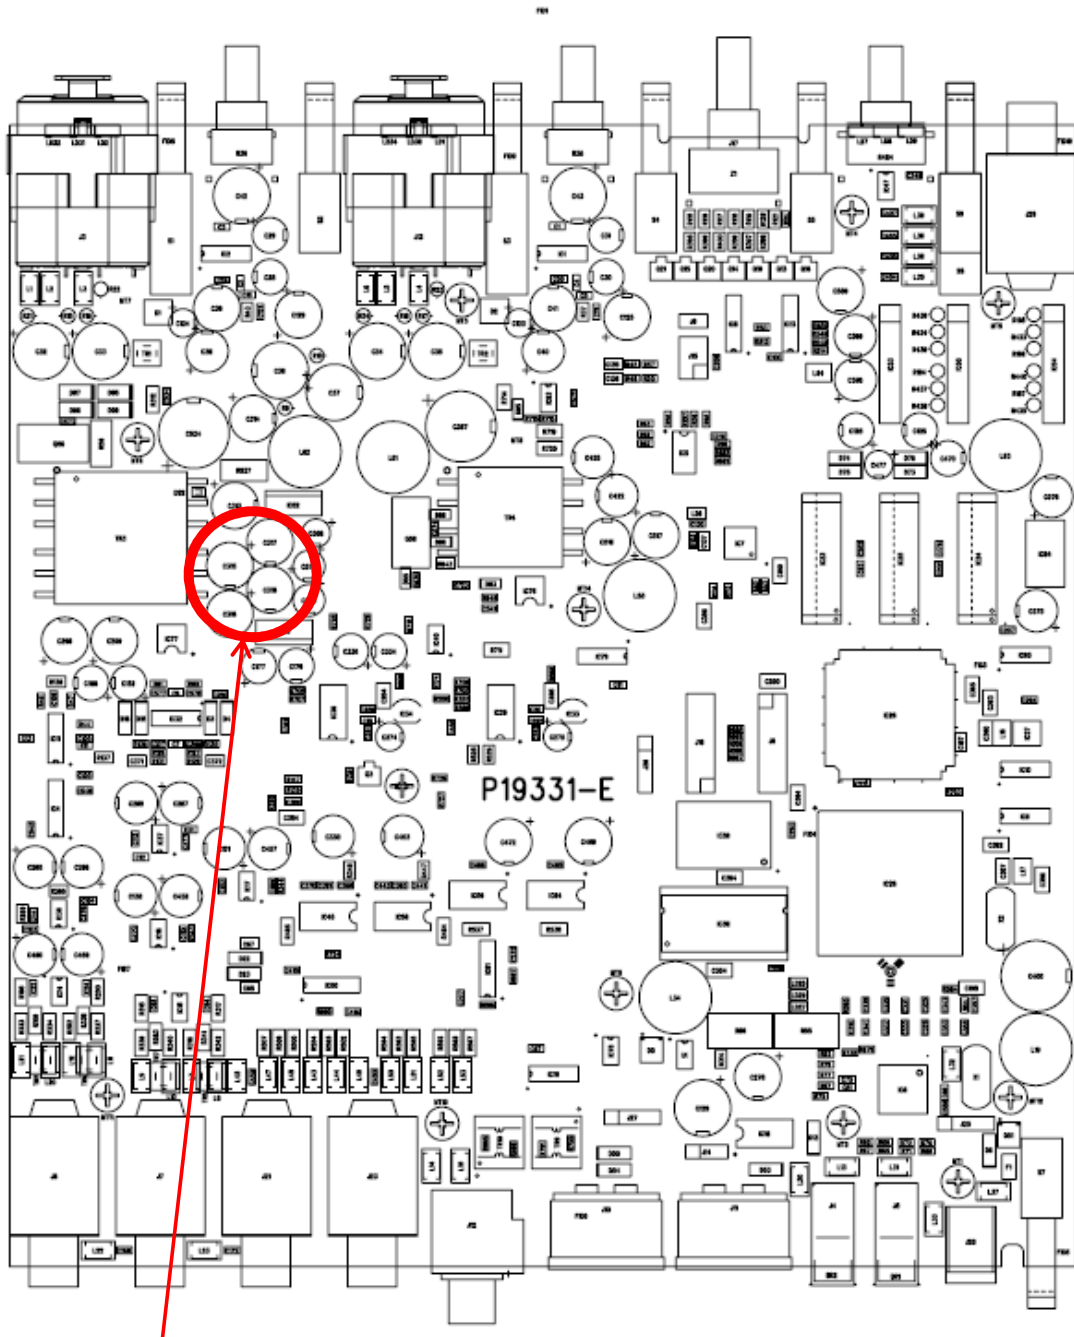
We have seen cases where the product, if exposed to extensive heat or situated in an heated environment, mutes the audio permanently.

The incidents we have analyzed are caused by the analog 12 volt which has dropped down to some 8 volt followed by triggering of the mute circuit.

Our investigations show that it is caused by degrading of C315, C316, C317 and C318 if these are Hitano types.

If C315, C316, C317 and C318 are Hitano types it is our recommendation that these are replaced. However if the Impact Twin is within the warranty period these must be replaced.

A package of 4 capacitors for replacement has TC stock no 7E22301699
