Service Note

Product	Description:	Service note no.
BG250 / BH250	Hissing noise from power supply	SNo-T0184

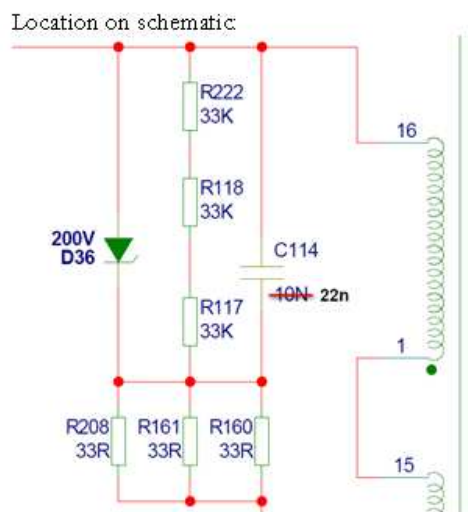
This is caused by a ceramic capacitor C114 of value 10nF/1000V placed in the primary switch snubber circuit.

To reduce the hissing noise level, C114 must be replaced by a film capacitor with the value of 22nF/400V (7E20404711). Affected production BOM's are all revision from EAA to EAE. The change has been implemented from version P18114-EAF.

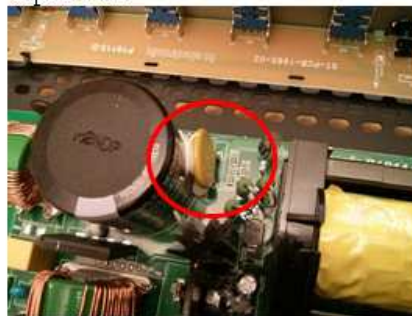
Replace this:

Some of the power supplies in the BG/BH250 models tend to make a hissing sound.
