Service Note		
Product	Description:	Service note no.
BM5 MKIII and BMCompact MKIII	Ground Loop Noise	SNo-T204

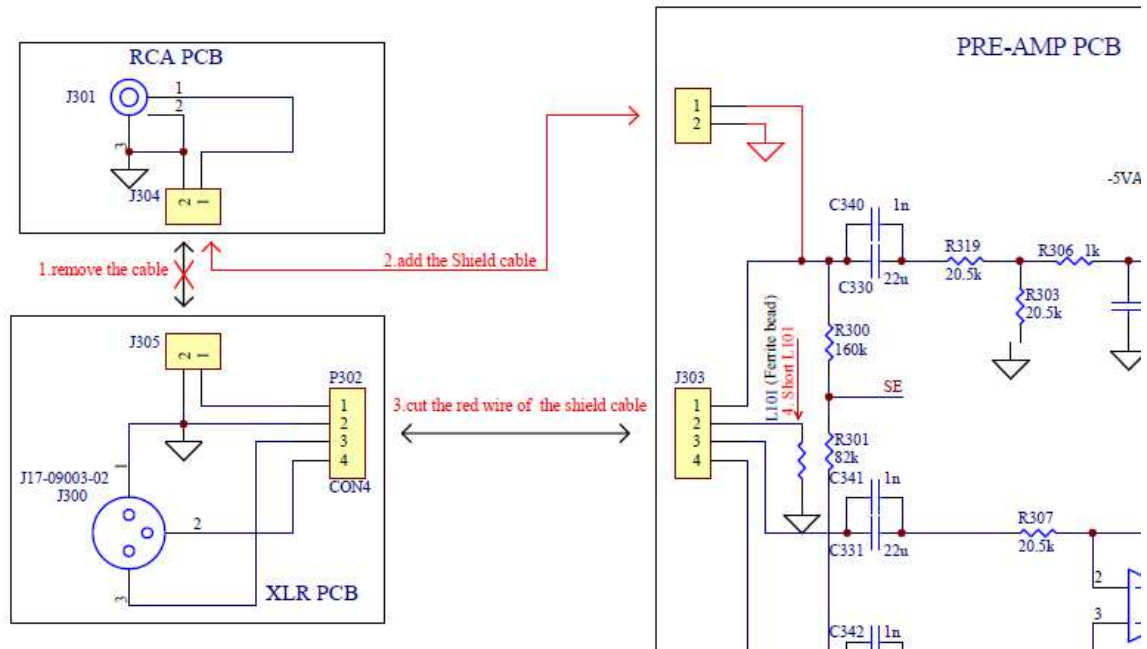
Due to a ground loop, these speakers may create a feeble noise.

To eliminate the noise, the following changes can be applied. We will refer to the below numbers on the following pages in this instruction
