Technical Service Bulletin No. 42

Created by: Music Tribe Brands Sweden AB Service Department

Reference no: SP40PFC

D40:4L

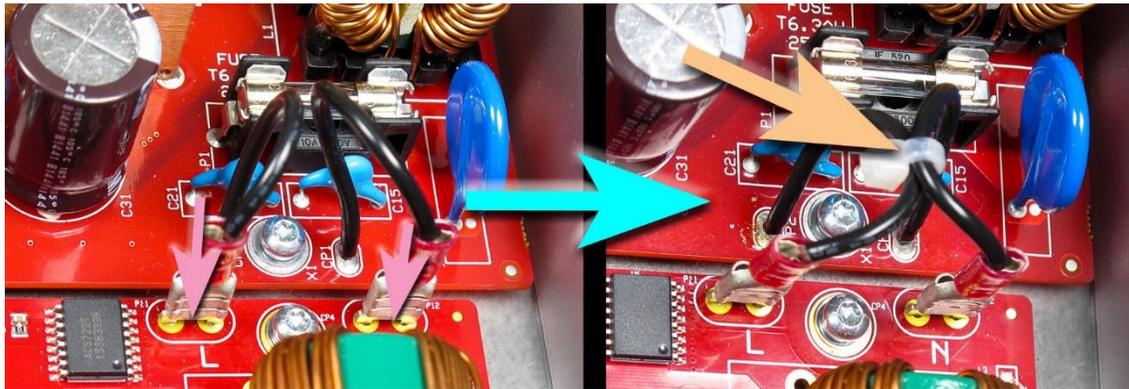
Remove the cables shown in the picture below

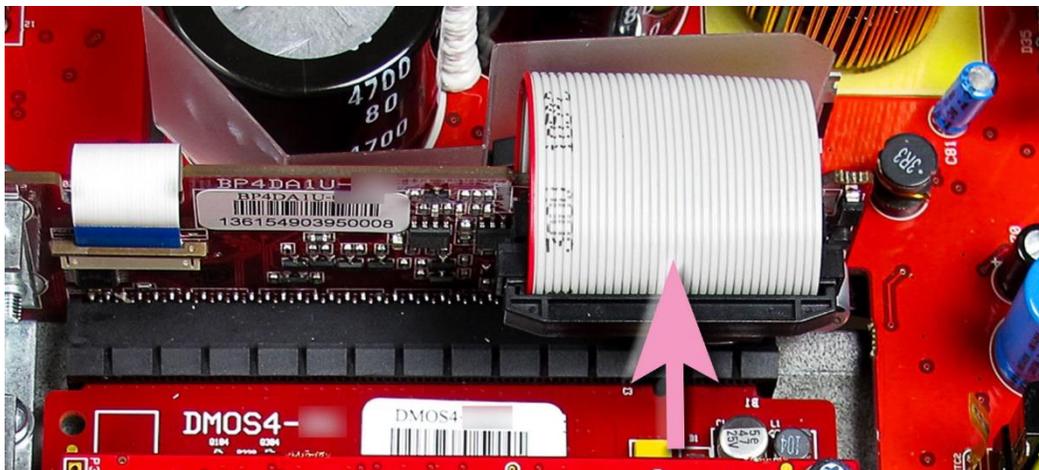
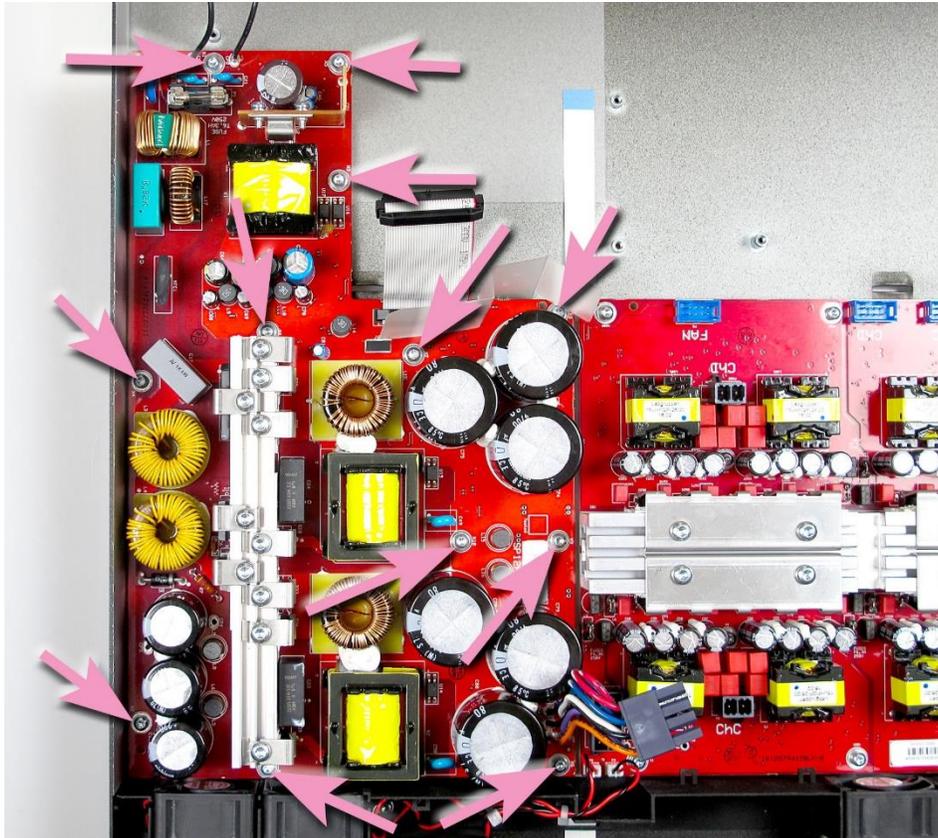
Remove the ribbon cable attached to the BP4DA1U-XXX
