# Technical Service Tip SCBA-XXX

Created by: Music Tribe Brands Sweden AB Service Department

Reference no: SCBA-01Ab

Following models are affected by this service tip: IPD2400

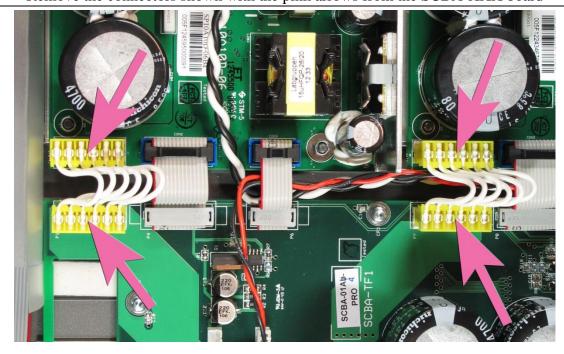
Remove the connectors shown with the pink arrows from the SCBA-XXX board

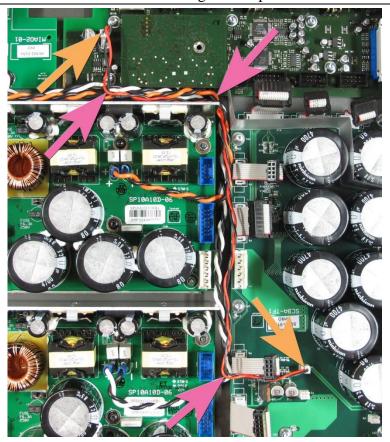
# Remove the connector shown with the orange arrow placed on the SCBA-XXX board

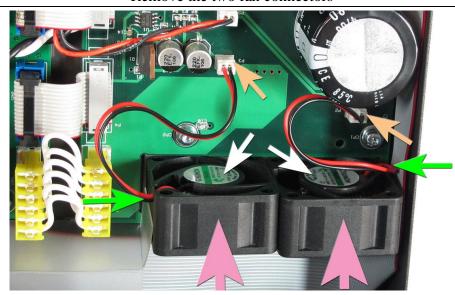
#### Remove the two fan connectors

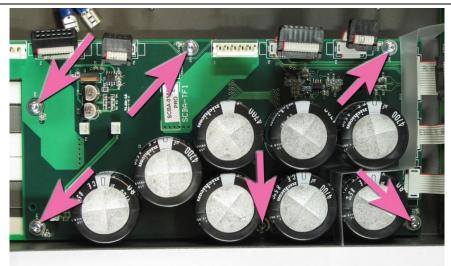
Remove the screws from the SCBA-XXX shown with the pink arrows, then remove the SCBA-XXX and mount the new SCBA-01Ab
