## **Technical Service Bulletin No. 23**

Reference no: Measure for broken NTC in DC/DC on SP200PCF

PLM20000Q

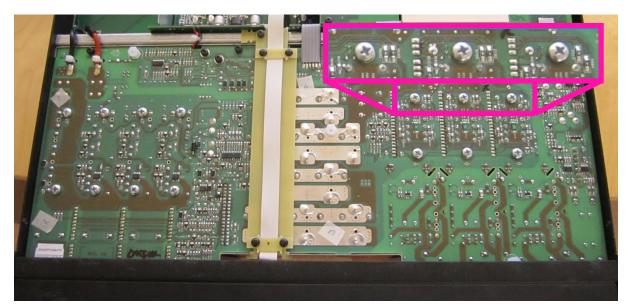
5.At room temperature, **Ohm measure**;<br/>NTC601, NTC702, NTC802~18kOhm to<br/>~20kOhm

Overview SP200 of which region of the board.

Ohm measure NTC601, NTC702 and NTC802. If outside ~18-20kOhm at room temperature, the NTC need to be replaced.

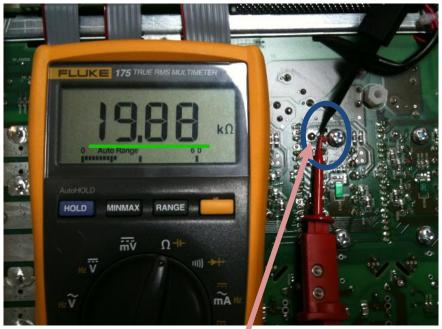
Example OK measurement of NIC702 on a **Rev8** SP200
