Technical Service Bulletin No. 26

Created by: Lab.gruppen AB Service Department

Reference no: Sense fault on PLM

PLM Series (PLM 10000Q, PLM 14000 and PLM 20000Q)

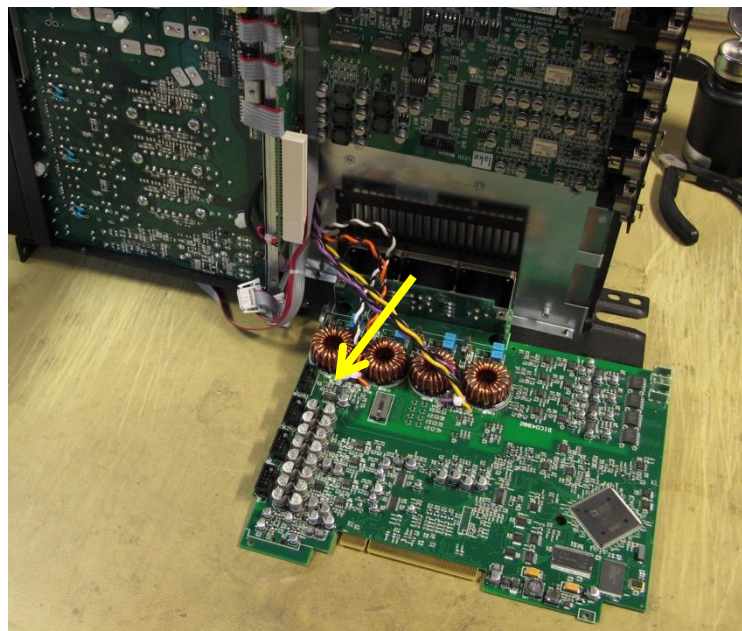
8.	Put down the DICO board as on the picture below. Arrow point to area of interest.		
----	---	--	--

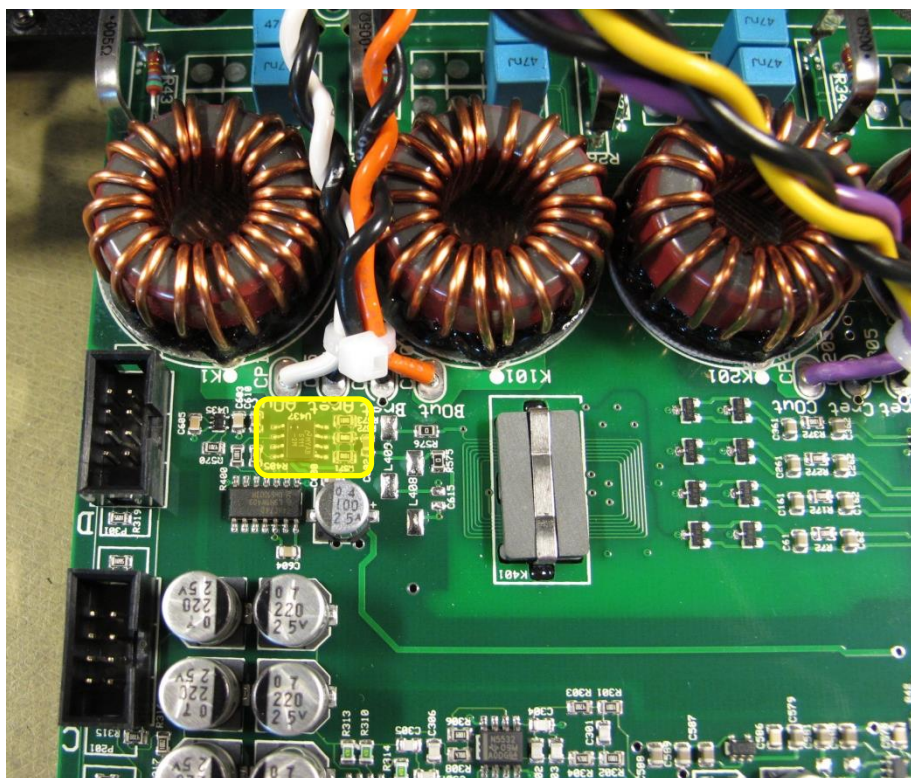
There is an IC that can break after time which will lead to a "Sense fault" warning on the front panel display. With sense fault, no output metering is available neither on the front panel nor in the Lake Controller.

9.	Highlighted with yellow, area with U437, R571, R572 and R573.		
----	---	--	--

Replace IC U437 and resistor R571, R572 & R573.
