# Technical Service Bulletin no. 29

**Created by: Lab.gruppen AB Service Department**

**Date: 20121124**

## Affected models

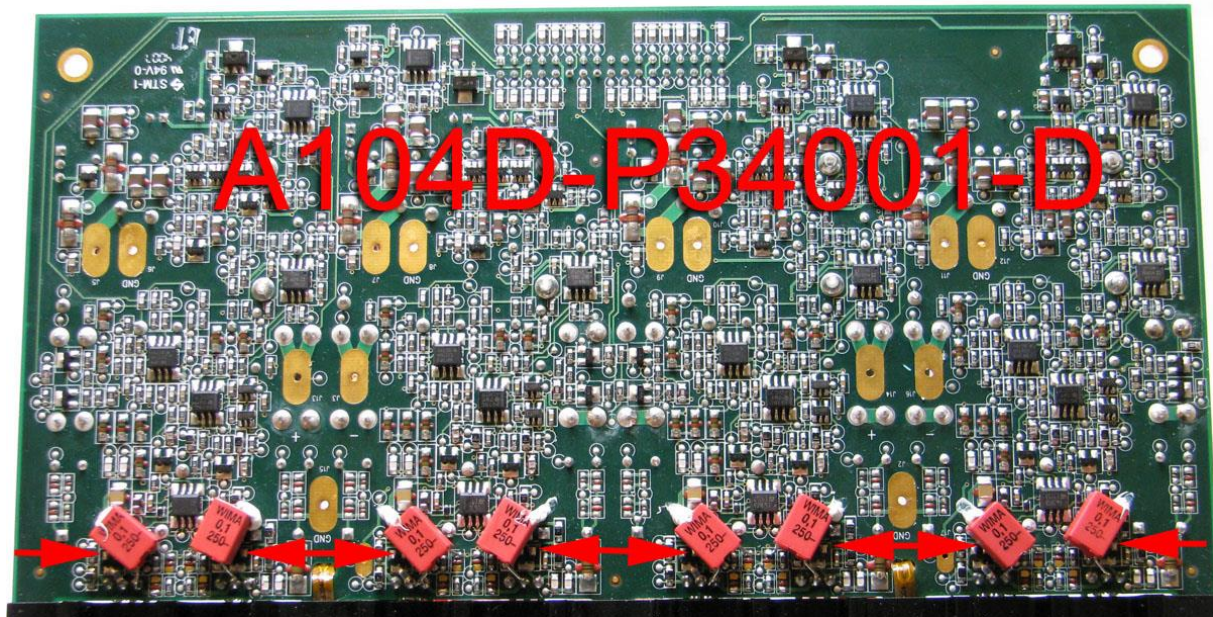
## Pic2

In the example in pic1, the “D” indicates the PCB revision number. Whenever you encounter a PCB revision number “D” or below, see if the capacitors are mounted like in Pic2 (see red arrows) then the board has been updated to the latest revision so you can continue repairing.

If they are not mounted you need to replace the A104D-P34001. See the spare parts list for the correct spare part.
