# ***Technical Service Bulletin No. 33***

***Created by: Lab.gruppen AB Service Department***

***Reference no: Ejected pins***

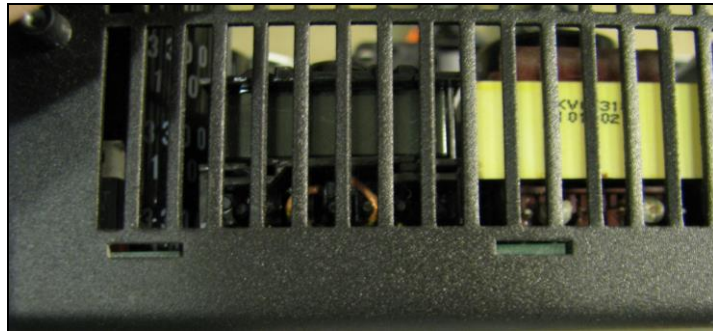
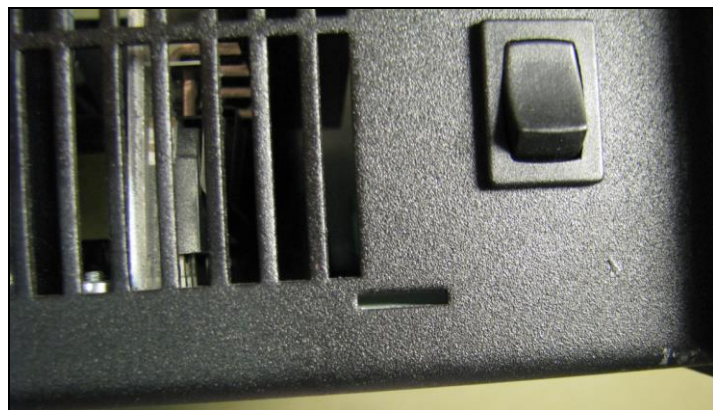
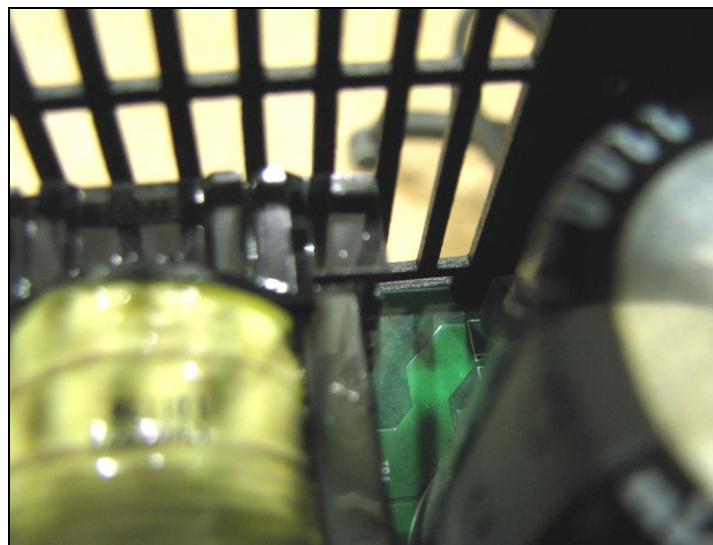
The PCB pins jump out of their slot on the front panel during transport. See pictures below.

### Examples of what it might look like.

If this has occurred, the SP20FXXX-XXX needs to be replaced, because we can't guarantee that it has not been damaged.
