# Technical Service Bulletin No. 34

**Created by: Lab.gruppen AB Service Department**

**Reference no: OVP on SP100F-SP130F**

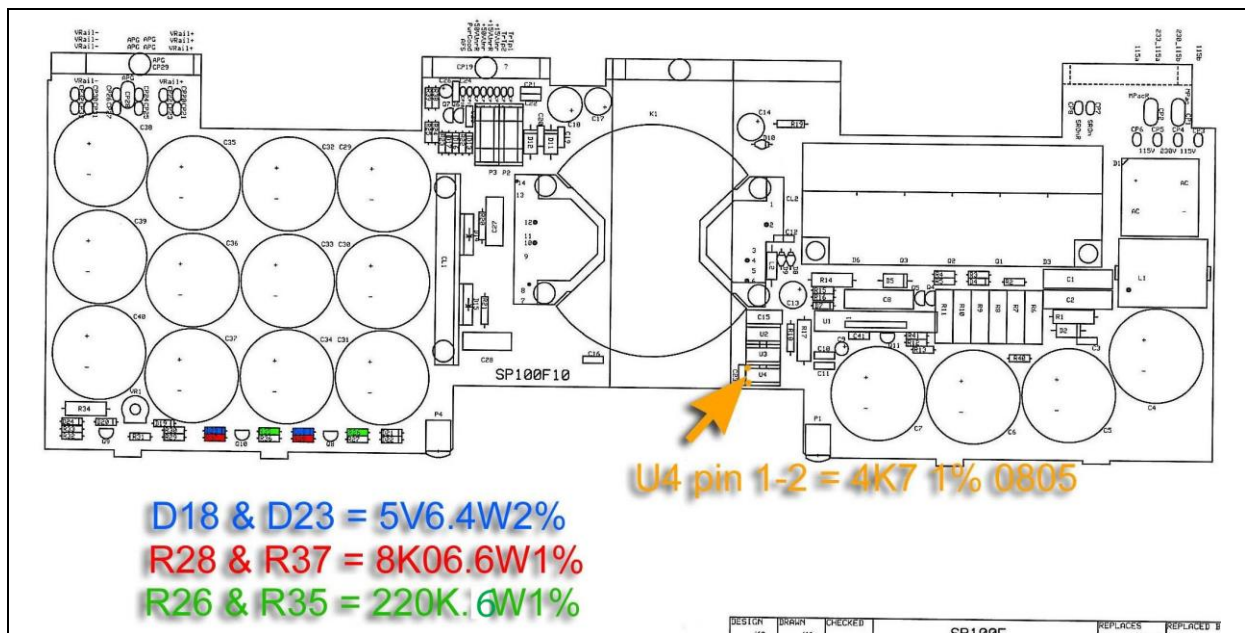
Unstable rail voltage, not able to adjust rail voltage.

PSU clicking on and off all the time and PAL led lights up.

Update the OVP circuit

Part No.	Description	Amount	Info	Pos
5V6.4W2%	Diode Zener 5V6 .4W 2%	2		D18, D23
220K.6W1%	Resistor Metal Film 220k .7W 1%	2		R26, R35
8K06.6W1%	Resistor Metal Film 8k06 .6W 1%	2		R28, R37
4K7.125W1% 0805	4K7.125W1%0805	1		U4 pin 1-2
SSP100F10d-FXX	Sticker SSP100F10d-FXX	1

1.	Note! 4K7.125W1% resistor is mounted on solder side		
----	---	--	--

between pin 1 & 2 .		
---------------------	--	--
