Technical Service Bulletin No. 35

Created by: Lab.gruppen AB Service Department

Date: 2014-03-27

Reference no: Protective insulation on SP200PFC

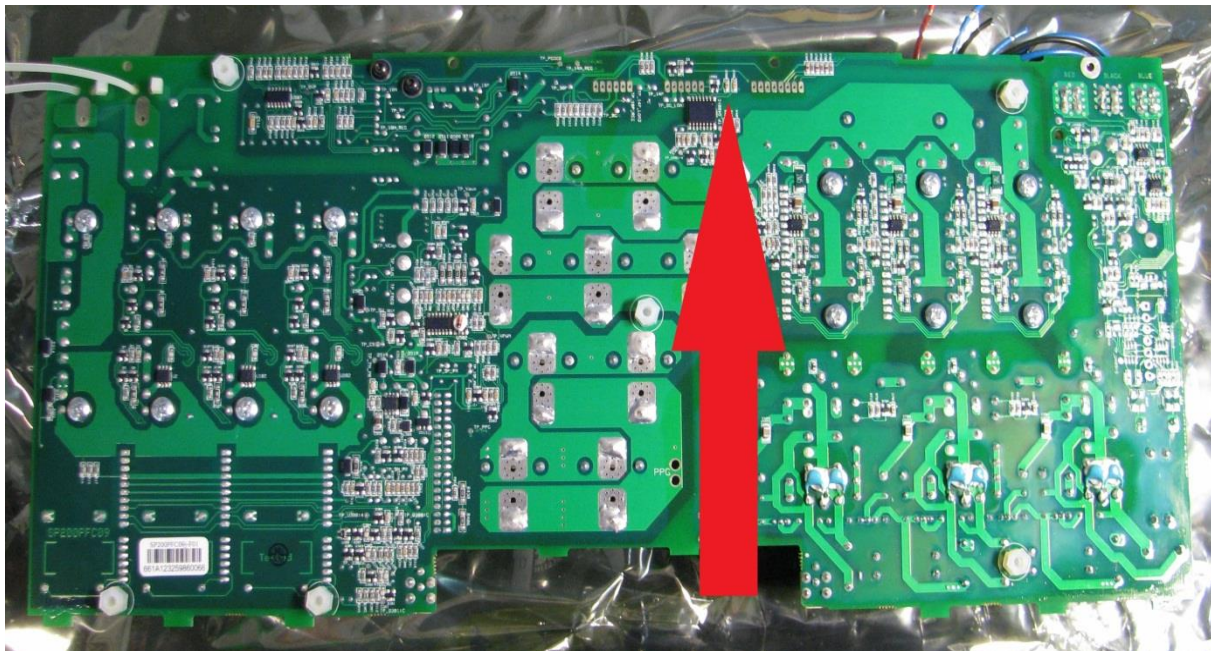
5.	Affected area		
----	---------------	--	--

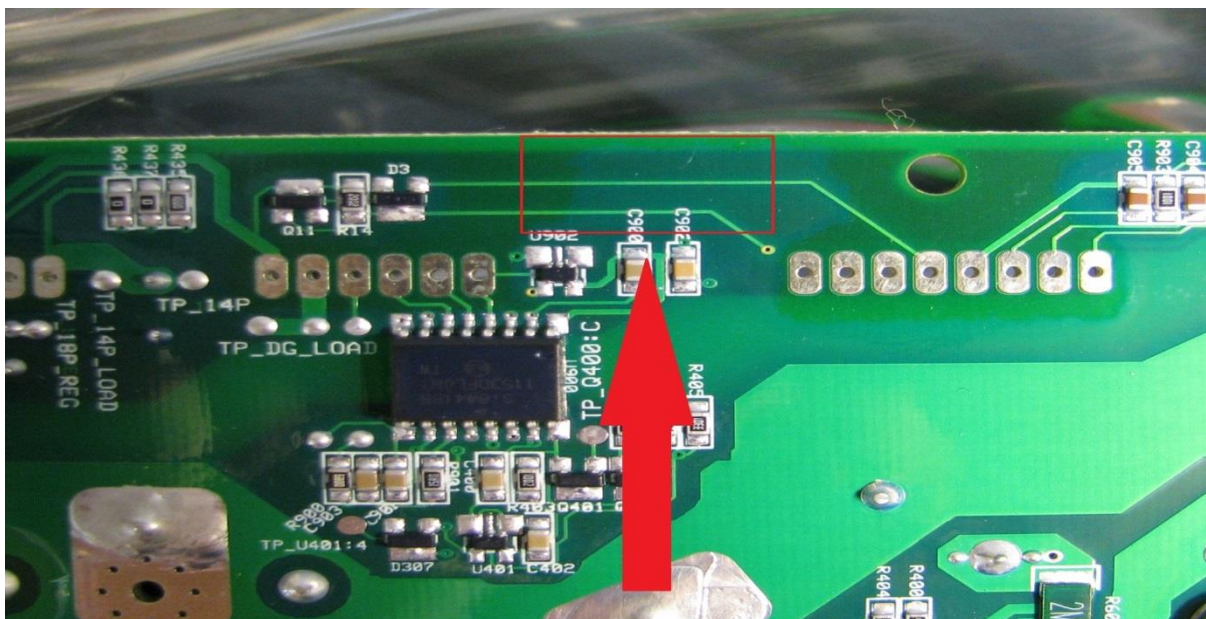
6.	Affected area		
----	---------------	--	--

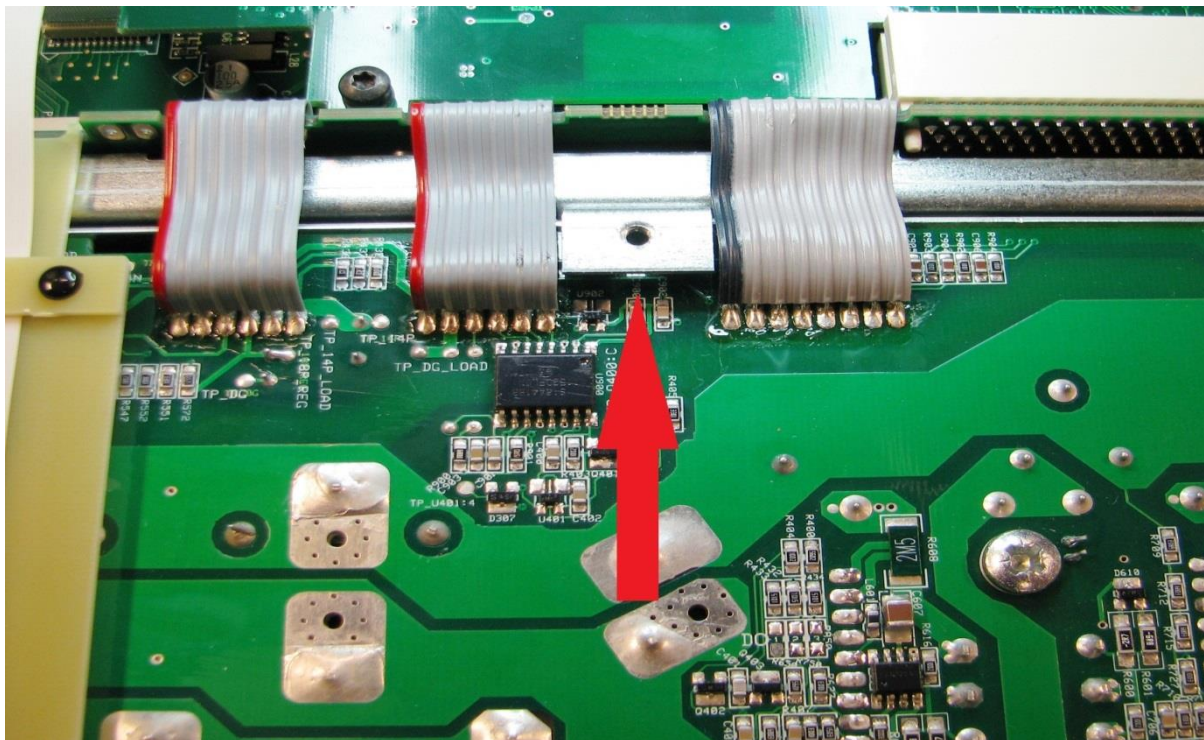
8.	affected area with the board inside the amp		
----	---	--	--
