Technical Service Bulletin No. 31

Created by: Lab.gruppen AB Service Department

Date: 2014-04-03

Reference no: 22N630VMKP7.5

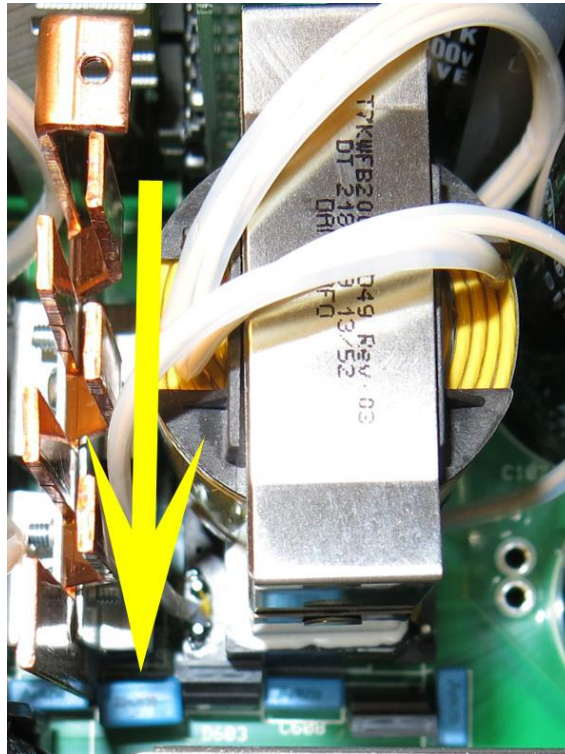
| 6. | Check if you have the faulty capacitor. The faulty capacitor is a color grey Vishay capacitor |

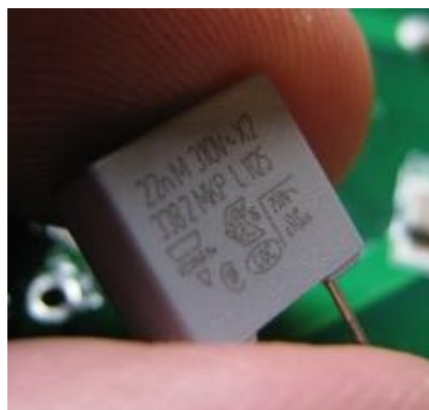
| 7. | This is the faulty capacitor it's the grey vishay capacitor. If you find this capacitor follow the instructions below on how to replace them |
