# Service Tips DLP board PLM

# Created by: Lab.gruppen AB Service Department Reference no: DLP board PLM

Following models are affected by this technical service tips: PLM 10000Q PLM 14000

DLP403b, DLP403c DLP404a, DLP404b, DLP404c DLP405a-F01

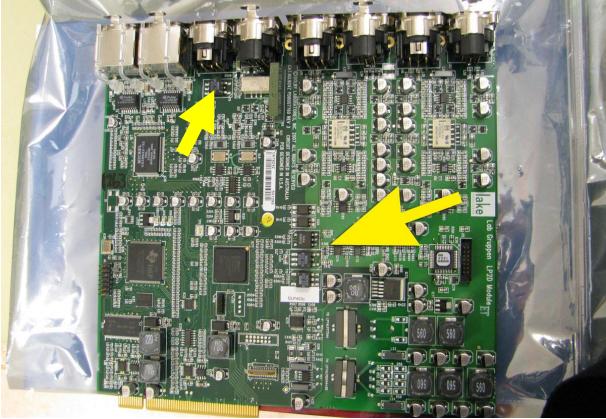
#### Pictures valid for all models of boards

Display says "analogue input fault".

The soldering can look ok but when checking close one or more pins at the transformer is not properly soldered. See pictures for example.

Check soldering at transformer, see picture. Re-solder pins at transformer.
