Service Note		
Product	Description:	Service note no.
M6K,DB8 DB4	Floppy Disk drive isolation	712 10 1840

Implemented from:	M6000:	S/N 287691
	DB8:	S/N 291233
	DB4:	S/N 291184

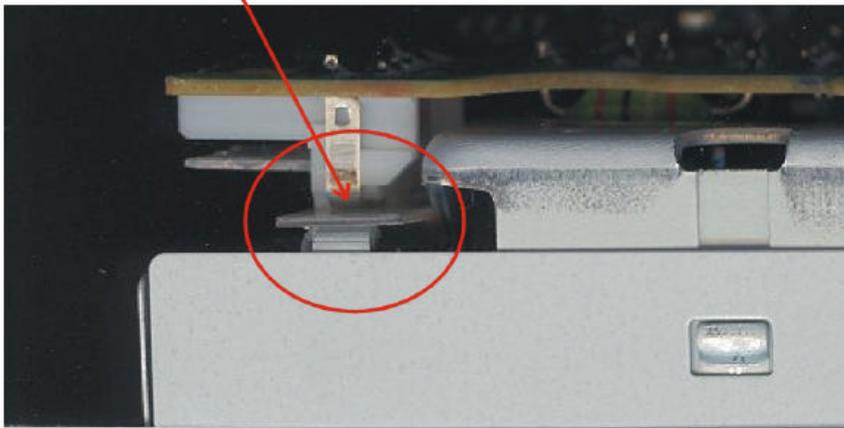
Figur 2

Symptoms: The power connector in the new Panasonic floppy disk has been changed to a type with a metal bracket. It is possible for this metal bracket to touch the floppy chassis and then make a connection between **CGND** and **DGND**. This causes ground loop problems, and the ground lift will not work probably.

- Place the two self-adhesive Mylar isolation shield under the power connector as shown in fig.2 top picture. Then put another Mylar isolation shield on the bottom lid in the corner see the lower picture in fig.2.

Place 16x7 millimeter mylar here
