Service Note		
Products	Description:	Service note no.
DB-max, D22, P2	Cut outs in alu foil on top cover	720101810

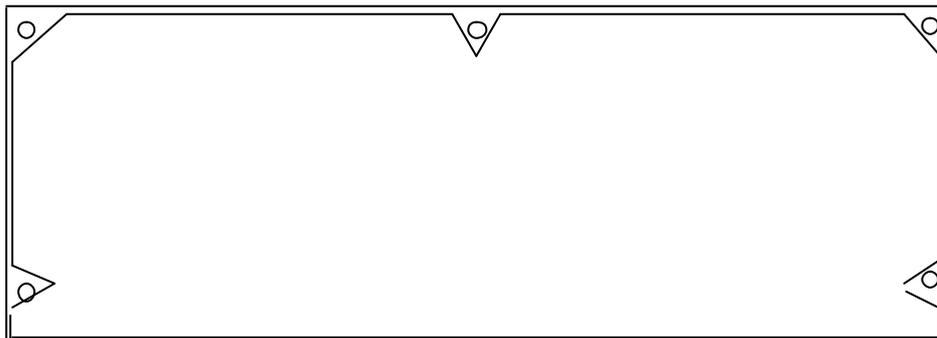
Due to observations with short circuits at IC pins caused by a chip of the aluminium foil which is stuck on the top cover of the above mentioned 3 Wizard products, we had to make a change in our production.

Top cover with stuck on alu foil, with the nescessary cut outs

Make cut outs in the foil where the screws come through the top cover. That must be done before the foil is stuck to the top cover according to the enclosed drawing.

Thereby the small alu chips which have caused short circuits should be eliminated.
