Service Note		
Product	Description:	Service note no.
WIZARD2	ADC malfunction after power on	720 10 T026

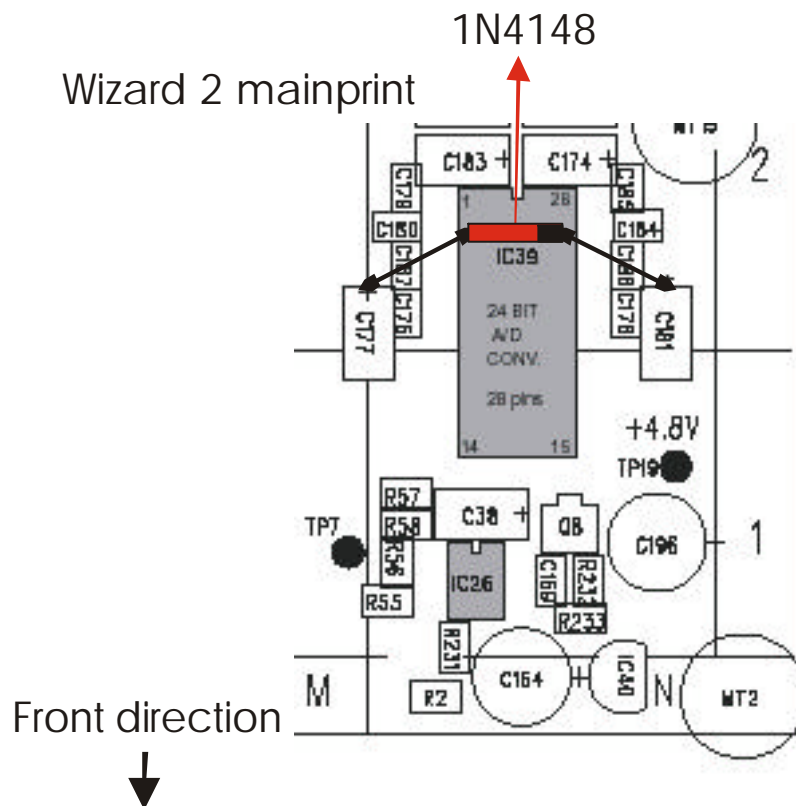
Fig.1.

A combination of potential overshoot on the PSU +5V during power ON and a sensitive local power design at the AD converter means that the ADC can brake and be malfunctioning after power ON cycle (no audio through ADC).

The solution is to mount a diode(1N4148) between the digital and analog +5V on the ADC. The PSU's must be production tested to make sure that the +5V is adjusted to 5.18V +/- 0.02V.

1. Make sure to power off the unit.
2. Solder the leaded diode 1N4148 like shown here in fig.1.
