Service Note		
Product	Description:	Service note no.
Wizard 2 series	Rare ADC latch-up	SNo-T0171

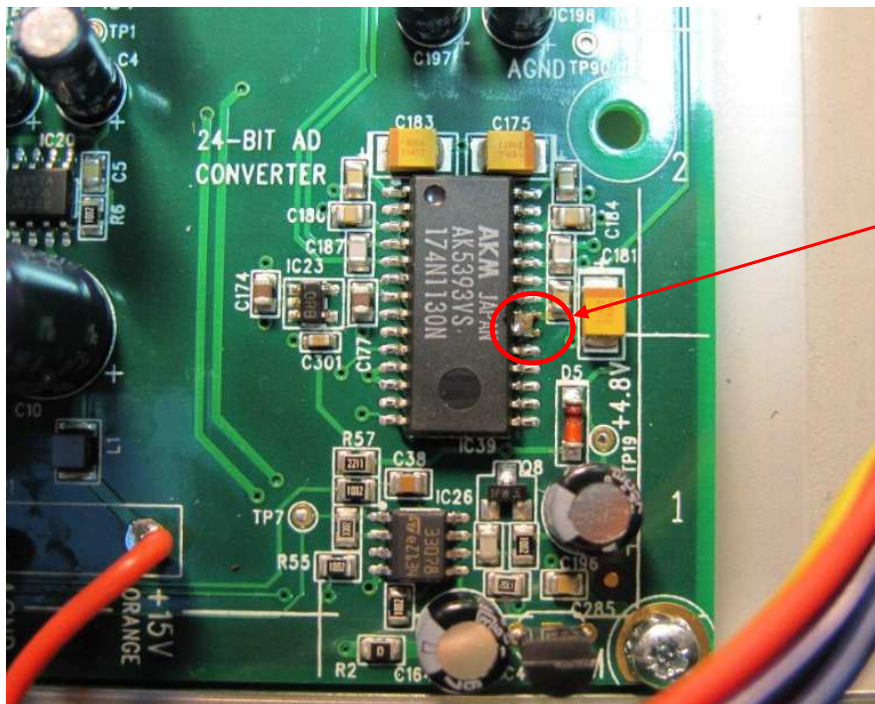
In very rare situations the ADC can latch-up during start-up. This results in ADC temperature rise, approx. 6dB audio input level reduction and THD at -40dB.

The solution is to connect the ADC IC39 AKM converter pin 20 and 21 by soldering them together.

Place a tin short between pin 20 and pin 21
