Service Note		
Products	Description:	Service note no.
G-System GFX box RH450, RH750, Staccato, Classic450	PLCC socket broken	SNo-T206

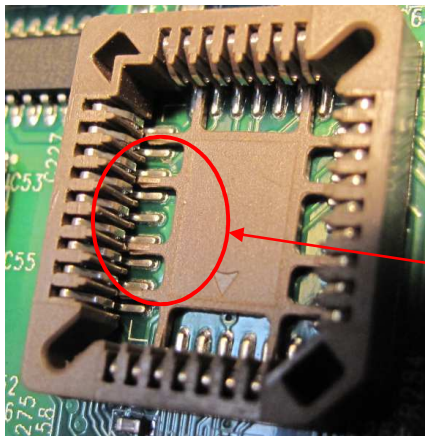
We have seen a few incidents where the sockets holding the flash were broken. It has been the small plate in the bottom, which were broken off. When this has happened and the flash IC is pressed all the way to the bottom of the socket is has none or bad contact to the contact springs in the socket. This can cause peculiar and weird errors, which most likely also can be intermittent. See pictures below:

Holdes for the bottom plate are broken off.

If you have one of the mentioned products in for service with an intermittent error, it could pay of to examine this socket. The quickest repair is to place a piece of 1 mm thick tape below the flash circuit. Please notice that not all Amp main boards have the flash in a socket.

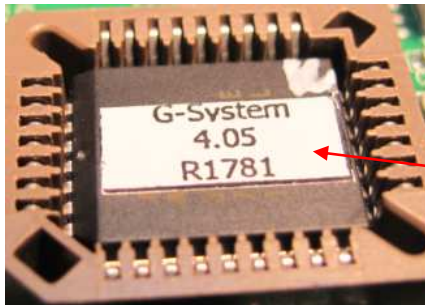
The IC pins gets poor or no contact to the socket contacts when pressed too deep into the socket
