Service Note		
Products	Description:	Service note no.
Voicelive 3 and Voicelive 3 Extreme	Improvement of boot up reliability and stability during operation	SNo-T214

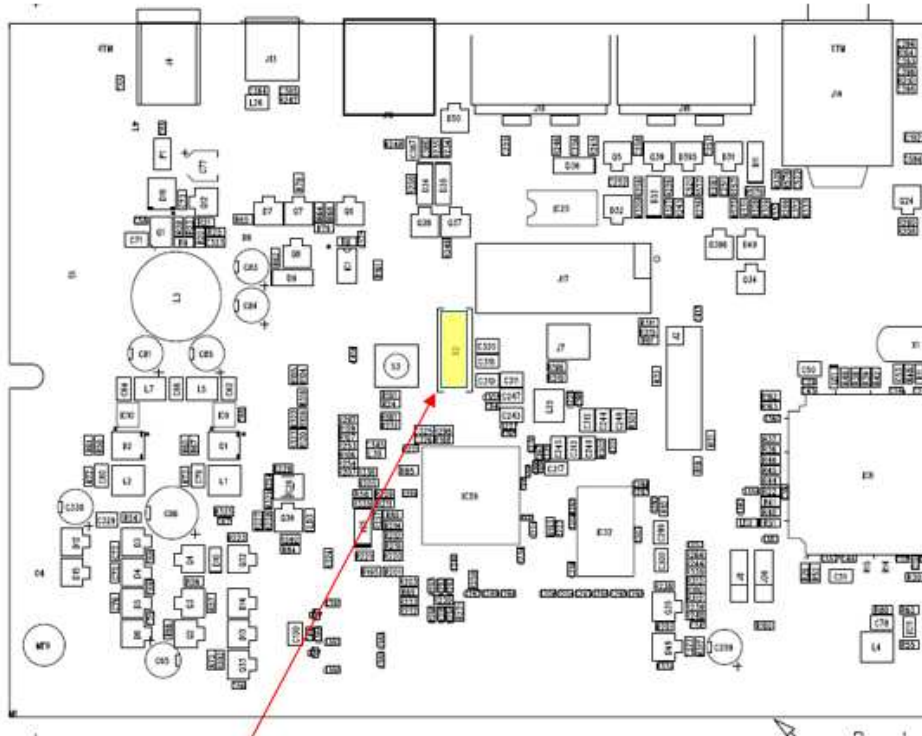
X2 is located here

We have experienced a big manufacturing spread in the Abracon crystal, which some times have made the main oscillator network unreliable. This can cause boot up problems and poor stability during operation like for instance blue screen (freeze).

- X2 to be replaced with new ECS type (ECS-240-12-5PX-TR)
- C260 and C261 to be replaced with new 10 pF COG types
