# Service Tips C12

**Created by: Lab.gruppen AB Service Department**  
**Reference no: C12**

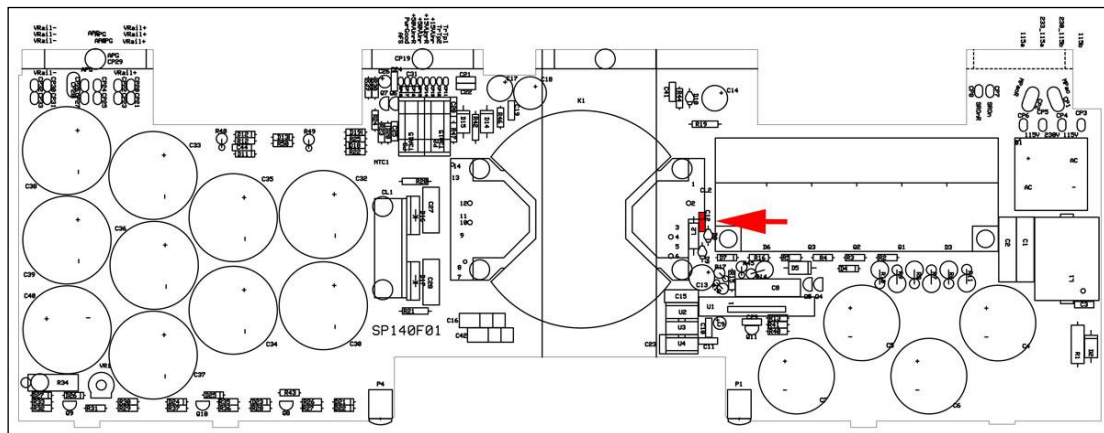
Screaming sound from power supply if amplifier powers up.

Amplifier does not power up.

Replace capacitor C12 with either of below listed components.
