Technical Service Bulletin No. 41

Created by: Music Tribe Brands Sweden AB Service Department

Reference no: BP4DA1U

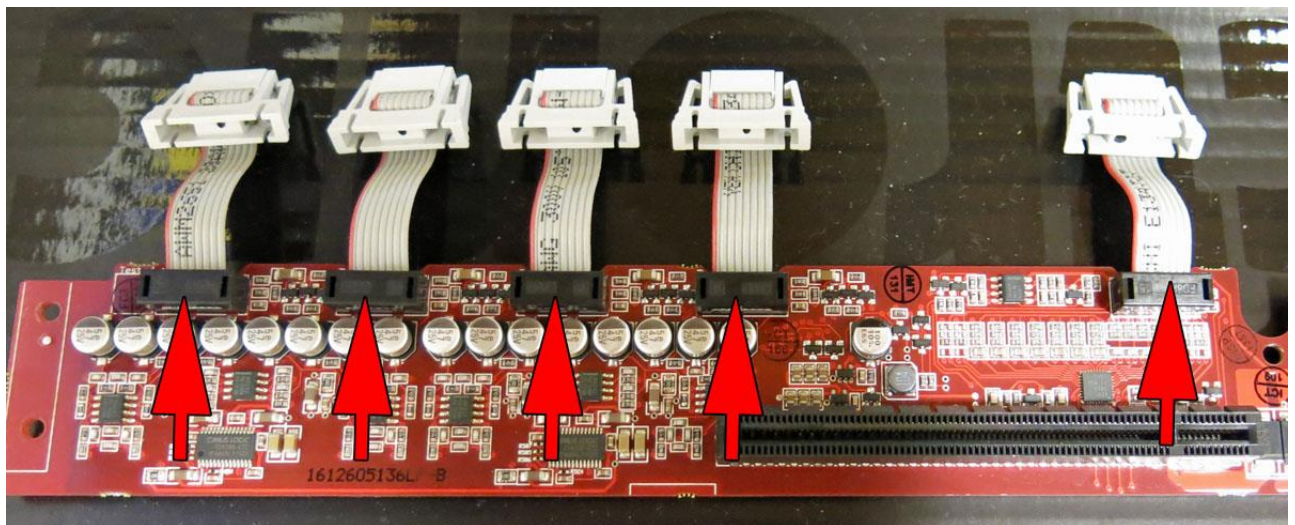
Costumer can experience loss of performance

Replace highlighted ribbon-cables (5pcs). If you replace the cables make sure to write SB41 on the board
