Service Note		
Product	Description:	Service note no.
TC2290	"Scratch" When Turning Gain-pot:	706 10 T067

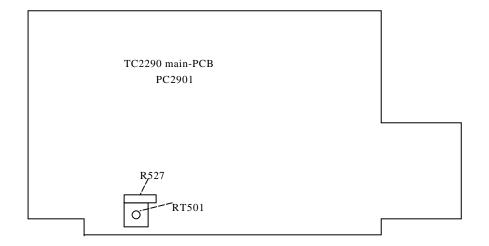
Please cut out R527 that are placed just besides of the RT501. Removing R527 will eliminate the sound to "Scratch" when turning the gain-pot.

IMPORTANT: When having 2290s with s.no. lower than 510335 for repair or service please make this correction.
