VoicePrism Plus Noise Solution

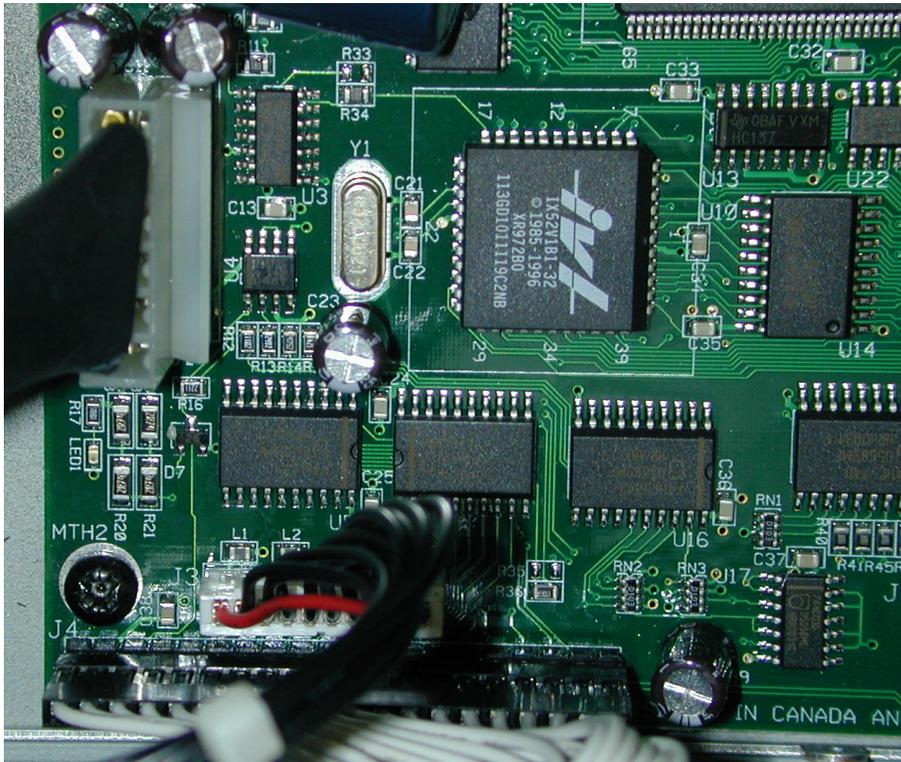
1. Open top cover of VoicePrism Plus.
2. Locate MTH2 mounting hole near the front of the unit on the side of the power supply. (see bottom right hand corner of picture below)

Connect MTH2 to ground.

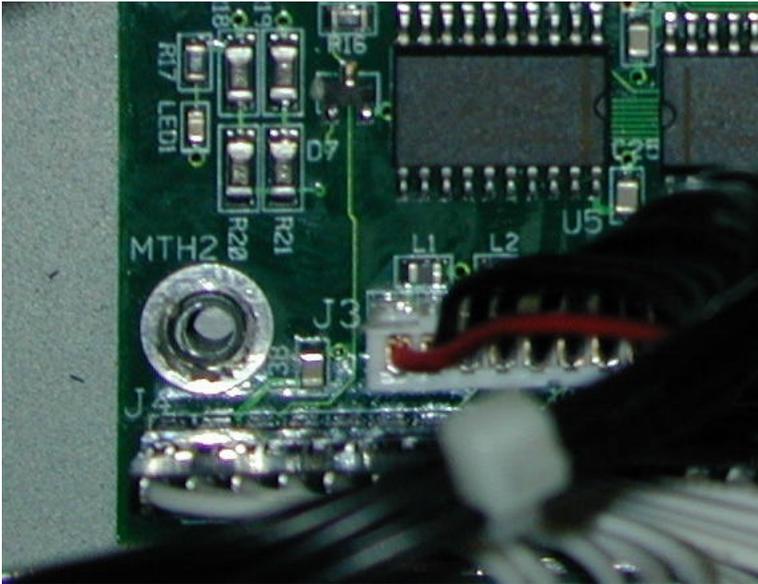
3. Remove machine screw from MTH2 as shown below

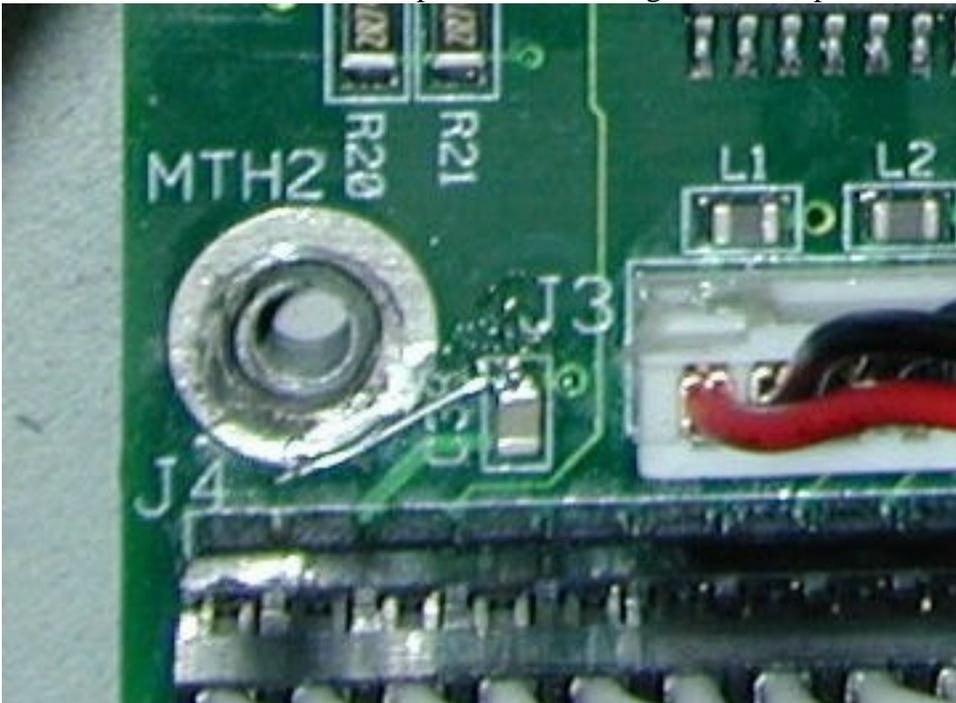
4. Solder a wire from the top of C38 to the edge of MTH2 pad as shown below

5. Replace the screw back to position MTH2 and put cover back on the VoicePrism Plus.
