Service Note		
Product	Description:	Service note no.
AIR PSU	C11 sometimes derates too quickly	SNo-T0148

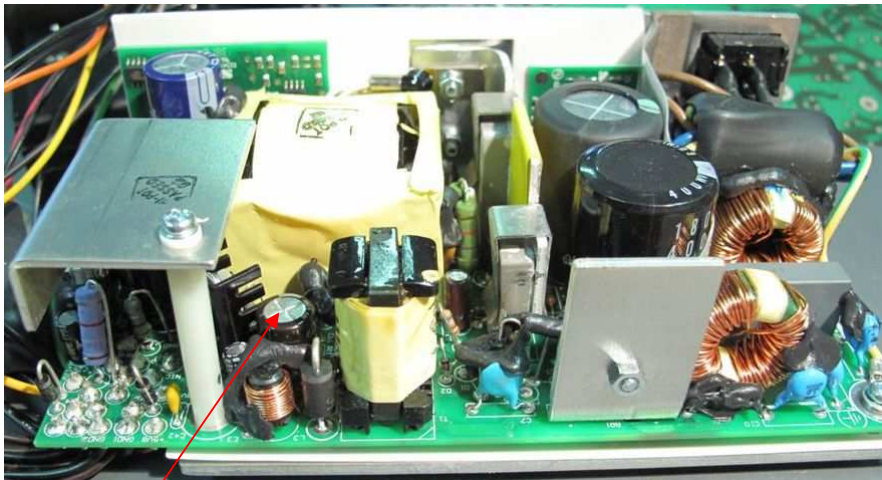
We have experienced that C11 in our AIR PSU under some circumstances derates too quickly. That makes the 3,3 V unable to start up and thereby of course make the AIR unit to fail. We have as of today redesigned C11 to a capacitor with better performance when it comes to lower impedance at high frequency range and tolerantly to high ripple current.

C11: 1000µF,10V, high performance type.

When an AIR module is in for service it is advisably to check if C11 shows evidence of being exposed by internal high pressure. If so it is recommended to change it. Does the AIR power supply malfunction it is a good hint to start troubleshooting by paying C11 attention. When replacing C11 it is essential to use the capacitor specified from TC Electronic with low impedance and resistant for high ripple current. TC Order number: 223534011.
