| Service Note | | |
| BH250 | Spacers not fastened sufficient | SNo-T0174 |

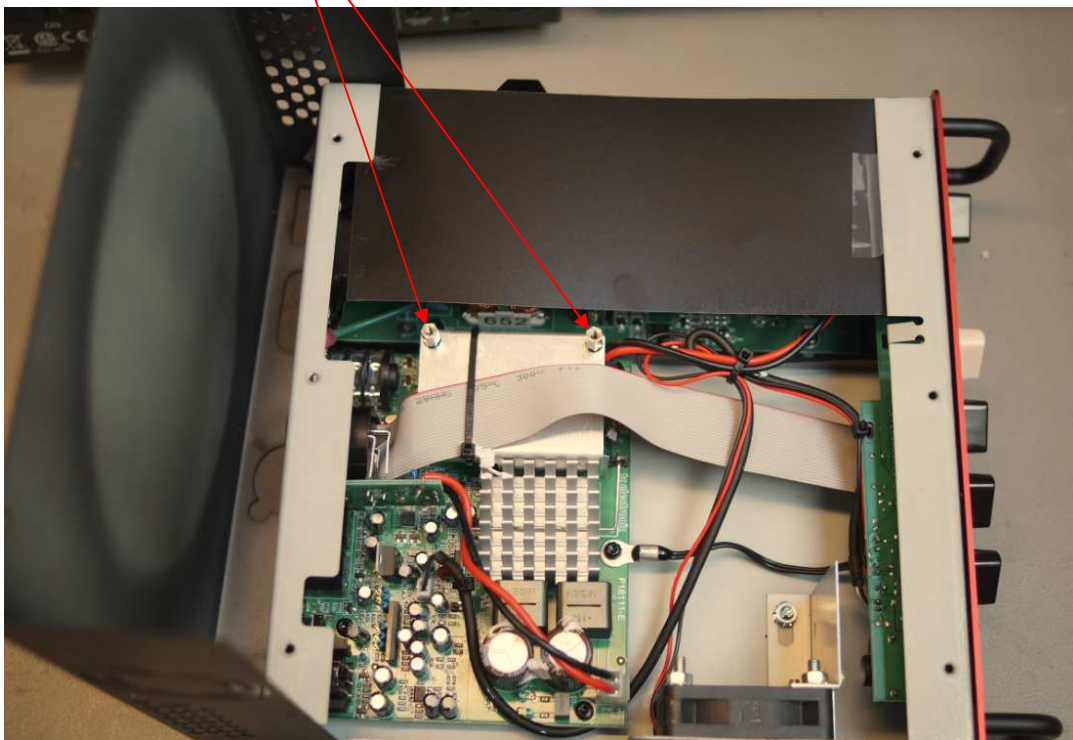
We have for a couple of production batches of BH250 sold in last half-year 2012 discovered 2 spacers and 2 screws which may not be fastened sufficient. This may cause a safety issue.

Make sure that the 2 spacers are securely fastened (torque = 65 Ncm)

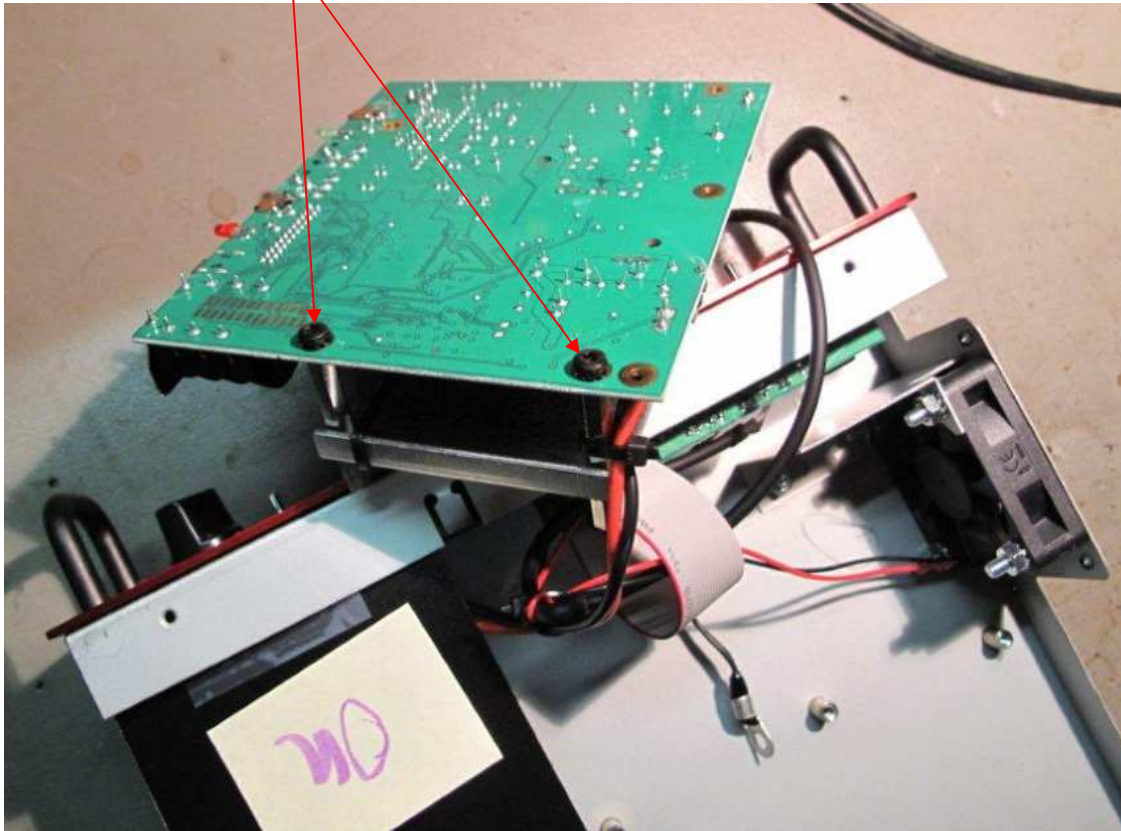
To access the 2 screws necessary to check, you have to take out the main board as shown. Make sure that the 2 screws are securely fastened (torque = 65 Ncm)

After making sure the screws and spacers are fastened correct, the main board shall be mounted again. Please pay attention that the mylar foil is placed correct.

It is recommended to place a paint mark dot or similar on the aluminium plate close to the spacers to indicate that this unit has been checked.
