Service Note		
Product	Description:	Service note no.
BH250 and BG250 208	Fan is running full speed	SNo-T0193

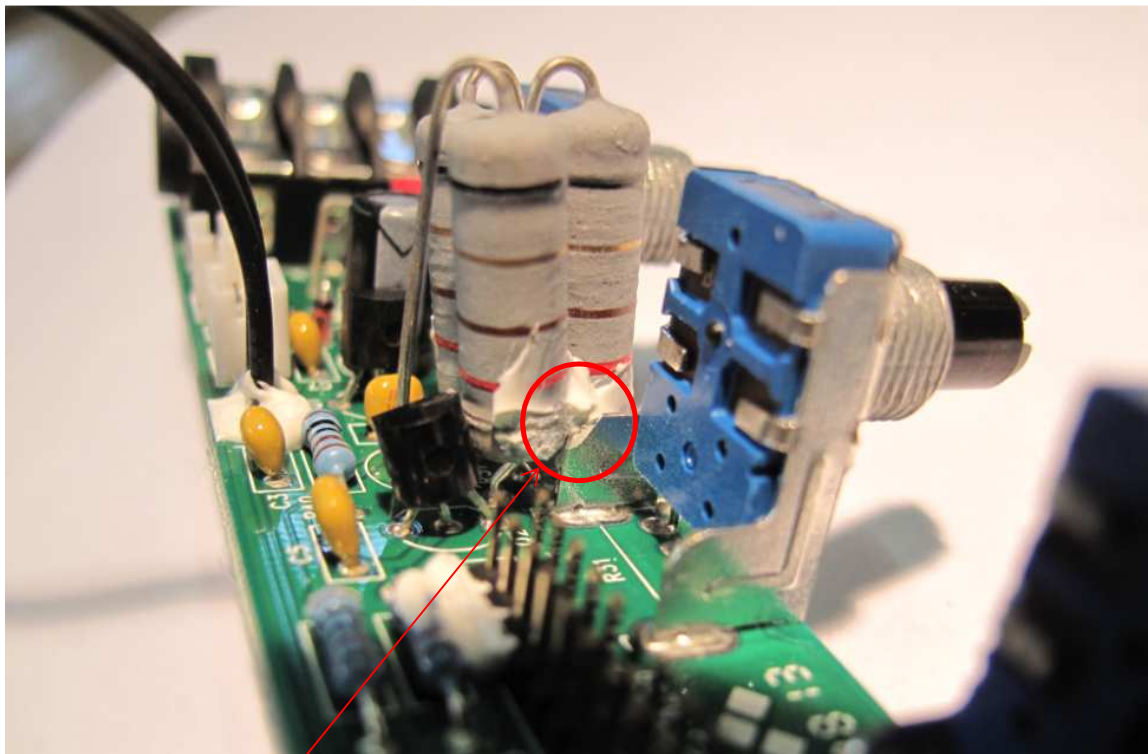
We have seen a few incidents where the housing on potentiometer R31 makes a short circuit to the housing of resistor R37. The housing of these resistors are conductive right under the lacquering on the surface . This short circuit is causing the fan to run at full speed right after switching on the product.

If you have a product in for service with this issue you have to pay attention to a possible shortcircuit.

Please check that the metal housing of the potentiometer doesn't touch the resistor.
