Service Note		
Product	Description:	Service note no.
BMCompact MKIII	Cure to RFI problems	SNo-T196

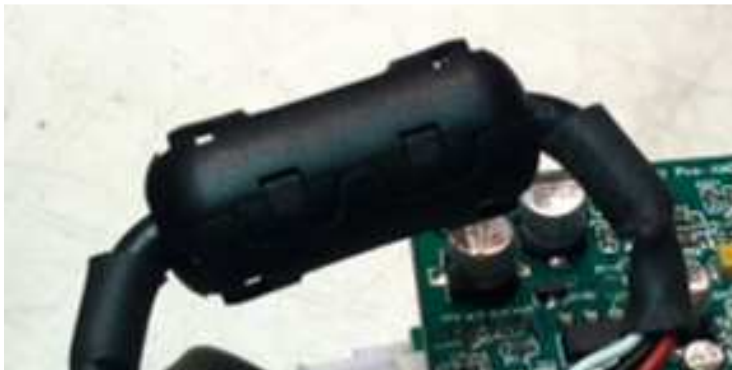
Close the snap-on ferrite:

- *Reconnect connectors from drivers to board*
- *Replace module back in the cabinet and fasten 8 screws back.*
- *Test the unit .*
